Access Compliance Report

Public Rights-of-Way

(Curb Ramps)

Intersection ID: 53633	Main Street: TREMONT_RIDGE_CT	Cross Street: BEACON_VALLEY_ST	Location: E
ADA ID: 4C8D77D6C940	Ramp Type: PerpDiag	Initial Pass/Fail: Fail	Overall Compliance: No
		Severity Score: 25

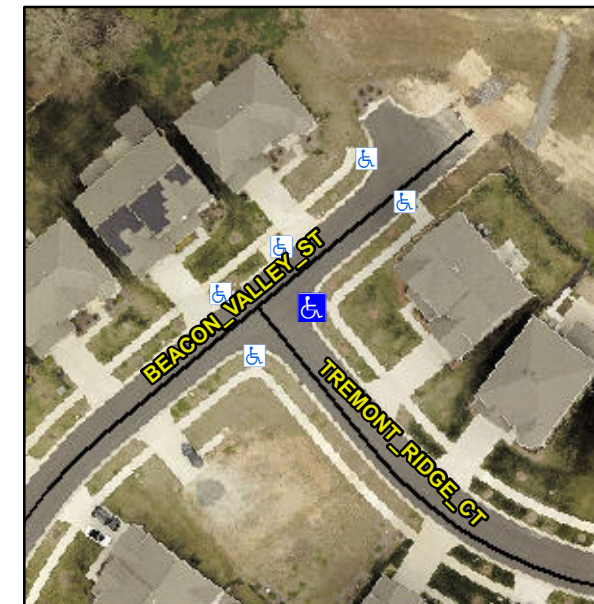
Not Found, R304.5.3

Compliance	Description	Data	Compliance	Description	Data
N/A	Ramp Length (in)	94.0	Yes	Ramp Slope (%)	5.7
Yes	Ramp Width (in)	48.0	No	Ramp XSlope (%)	10.2
N/A	Flare Type LT	N/A	N/A	Flare Type RT	N/A
N/A	Flare Slope LT (%)	N/A	N/A	Flare Slope RT (%)	N/A
N/A	Flare Traversable LT?	N/A	N/A	Flare Traversable RT?	N/A
N/A	Landing Length (in)	N/A	N/A	DWS Provided?	N/A
N/A	Landing Width (in)	N/A	N/A	DWS Contrast?	N/A
N/A	Landing Slope (%)	N/A	N/A	DWS Length (in)	N/A
N/A	Landing X Slope (%)	N/A	N/A	DWS Full Width?	N/A
N/A	Landing Curb? (Y/N)	N/A	N/A	DWS Offset (in)	N/A
N/A	Shared Landing?	N/A			
N/A	Gutter Ponding?	N/A	N/A	Gutter Slope (%)	N/A
N/A	Gutter Lip Ht (in)	N/A	N/A	Gutter X Slope (%)	N/A
N/A	Painted X Walk1?	No	N/A	Painted X Walk2?	No
	X Walk 1 Direction	To NW		X Walk 2 Direction	To SW
N/A	X Walk 1 Width (in)	N/A	N/A	X Walk 2 Width (in)	N/A
	X Walk 1 Slope (%)	6.1		X Walk 2 Slope (%)	13.4
	X Walk 1 X Slope (%)	11.3		X Walk 2 X Slope (%)	2.2

N/A	Ramp inside XWalk1?	N/A	N/A	Ramp inside XWalk2?	N/A
	Road Slope (%)	10.2	N/A	Clear Space?	N/A
	Road X Slope (%)	10.1	N/A	Clear Space to XWalk (in)	N/A
N/A	Any Obstructions?	N/A	N/A	Storm Grate/Utility Hazard?	N/A
	Obstruction Type			Storm Grate/Utility Type	
		N/A			N/A
			Yes	Surface Condition? (G/P)	Good

Remove & Replace Curb Ramp With Two New Directional Ramps or Equivalent.
