# Access Compliance Report

## Public Rights-of-Way

### (Curb Ramps)

Intersection ID: 10234	Main Street: MCCARRON_WY	Cross Street: CRANBOURN_CT	Location: NW
ADA ID: 4C928E9A2A4E	Ramp Type: PerpDiag	Initial Pass/Fail: Fail	Overall Compliance: No
		Severity Score: 8.75

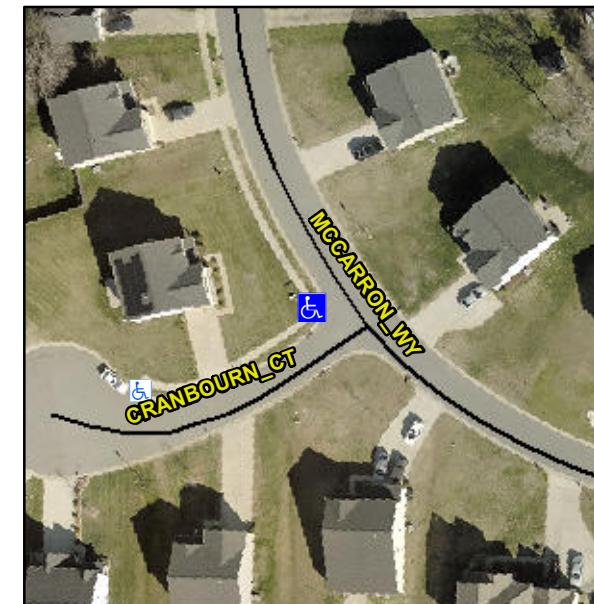
Compliance	Description	Data	Compliance	Description	Data
N/A	Ramp Length (in)	47.0	Yes	Ramp Slope (%)	7.1
No	Ramp Width (in)	46.5	Yes	Ramp XSlope (%)	0.8
N/A	Flare Type LT	N/A	N/A	Flare Type RT	N/A
N/A	Flare Slope LT (%)	N/A	N/A	Flare Slope RT (%)	N/A
N/A	Flare Traversable LT?	N/A	N/A	Flare Traversable RT?	N/A
N/A	Landing Length (in)	N/A	N/A	DWS Provided?	N/A
N/A	Landing Width (in)	N/A	N/A	DWS Contrast?	N/A
N/A	Landing Slope (%)	N/A	N/A	DWS Length (in)	N/A
N/A	Landing X Slope (%)	N/A	N/A	DWS Full Width?	N/A
N/A	Landing Curb? (Y/N)	N/A	N/A	DWS Offset (in)	N/A
N/A	Shared Landing?	N/A			
N/A	Gutter Ponding?	N/A	N/A	Gutter Slope (%)	N/A
N/A	Gutter Lip Ht (in)	0.5	N/A	Gutter X Slope (%)	N/A
N/A	Painted X Walk1?	No	N/A	Painted X Walk2?	No
	X Walk 1 Direction	To SE		X Walk 2 Direction	To E
N/A	X Walk 1 Width (in)	N/A	N/A	X Walk 2 Width (in)	N/A
	X Walk 1 Slope (%)	N/A		X Walk 2 Slope (%)	N/A
	X Walk 1 X Slope (%)	N/A		X Walk 2 X Slope (%)	N/A

N/A	Ramp inside XWalk1?	N/A	N/A	Ramp inside XWalk2?	N/A
	Road Slope (%)	0.8	N/A	Clear Space?	N/A
	Road X Slope (%)	0.8	N/A	Clear Space to XWalk (in)	N/A
N/A	Any Obstructions?	N/A	N/A	Storm Grate/Utility Hazard?	N/A
	Obstruction Type			Storm Grate/Utility Type	
		N/A			N/A
			Yes	Surface Condition? (G/P)	Good

Possible Solutions:

**Remove & Replace Curb Ramp With Two New Directional Ramps or Equivalent.**

**Not Found, R304.5.1**

Total Cost: \$ 3200.00

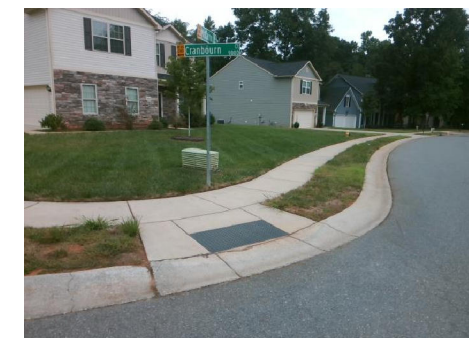
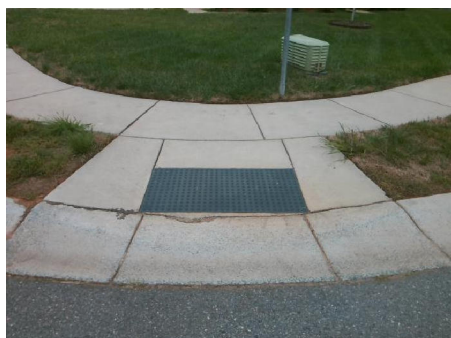
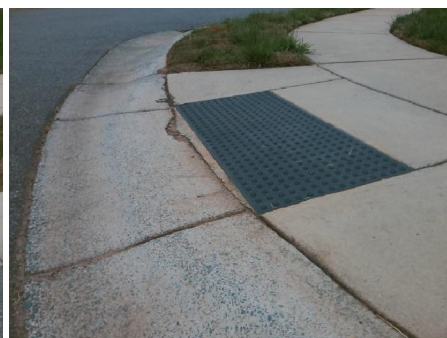
Street 1 Name CRANBOURN CY  
 Stop Condition-Street 2 StopSign  
 Street 2 Name MCCARRON WY  
 Stop Condition-Street 1 None
