Access Compliance Report

Public Rights-of-Way (Curb Ramps)

Intersection ID: 7558	Main Street: SQUIRREL_HILL_RD	Cross Street: YUMA_ST	Location: NW
ADA ID: 4C9717B6F982	Ramp Type: BlendTrans1	Initial Pass/Fail: Fail	Overall Compliance: No
		Severity Score: 10

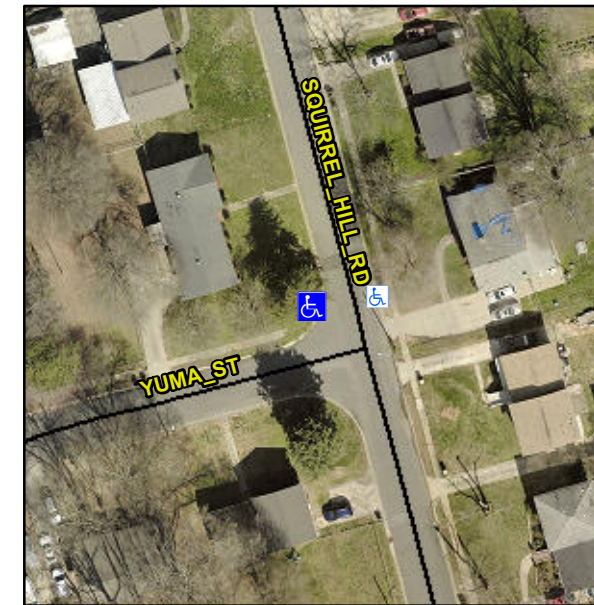
Not Found, R304.5.1

Compliance	Description	Data	Compliance	Description	Data
N/A	Ramp Length (in)	47.5	Yes	BlendTrans Slope (%)	4.0
No	Ramp Width (in)	44.0	Yes	BlendTrans XSlope (%)	3.5
N/A	Flare Type LT	N/A	N/A	Flare Type RT	N/A
N/A	Flare Slope LT (%)	N/A	N/A	Flare Slope RT (%)	N/A
N/A	Flare Traversable LT?	N/A	N/A	Flare Traversable RT?	N/A
N/A	Landing Length (in)	N/A	N/A	DWS Provided?	N/A
N/A	Landing Width (in)	N/A	N/A	DWS Contrast?	N/A
N/A	Landing Slope (%)	N/A	N/A	DWS Length (in)	N/A
N/A	Landing X Slope (%)	N/A	N/A	DWS Full Width?	N/A
N/A	Landing Curb? (Y/N)	N/A	N/A	DWS Offset (in)	N/A
N/A	Shared Landing?	N/A			
N/A	Gutter Ponding?	N/A	N/A	Gutter Slope (%)	N/A
N/A	Gutter Lip Ht (in)	N/A	N/A	Gutter X Slope (%)	N/A
N/A	Painted X Walk1?	No	N/A	Painted X Walk2?	N/A
	X Walk 1 Direction	To NE		X Walk 2 Direction	N/A
	X Walk 1 Width (in)	N/A		X Walk 2 Width (in)	N/A
	X Walk 1 Slope (%)	0.8		X Walk 2 Slope (%)	N/A
	X Walk 1 X Slope (%)	5.4		X Walk 2 X Slope (%)	N/A

N/A	Ramp inside XWalk1?	N/A	N/A	Ramp inside XWalk2?	N/A
	Road Slope (%)	5.4		Clear Space?	N/A
	Road X Slope (%)	0.8	N/A	Clear Space to XWalk (in)	N/A
N/A	Any Obstructions?	N/A	N/A	Storm Grate/Utility Hazard?	N/A
	Obstruction Type			Storm Grate/Utility Type	
		N/A			N/A
			Yes	Surface Condition? (G/P)	Good
			No	Curb Slope (%)	10.2

Remove & Replace Curb Ramp With Two New Directional Ramps or Equivalent.
