# Access Compliance Report

## Public Rights-of-Way

| Intersection ID: 50945 | Main Street: ANNAHILL_CT | Cross Street: BLAIREBETH_ST | Location: NE |
| ADA ID: 4C991EBF9D76 | Ramp Type: BlendTrans1 | Initial Pass/Fail: Pass | Overall Compliance: No |

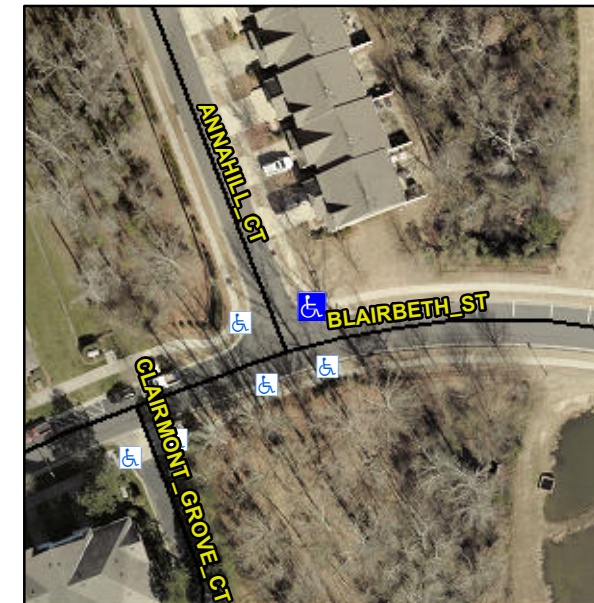
**Not Found, R304.5.3, R304.2.1, R305.2, R304.5.4**

| Compliance | Description | Data | Compliance | Description | Data |
|---|---|---|---|---|---|
| Yes | Ramp Width (in) | 48.0 | No | BlendTrans XSlope (%) | 2.4 |
| No | Landing Length (in) | 44.5 | Yes | DWS Provided? | Yes |
| N/A | Landing Curb? (Y/N) | No | No | DWS Offset (in) | 6.0 |
| Yes | Gutter Ponding? | No | No | Gutter Slope (%) | 8.7 |

**Remove & Replace Curb Ramp With Two New Directional Ramps or Equivalent. Remove & Replace Gutter.**
