# Access Compliance Report

## Public Rights-of-Way

### (Curb Ramps)

Intersection ID: N/A	Main Street: YORK_CENTER	Cross Street: N/A	Location: SE
ADA ID: 4C9C5C2C30BB	Ramp Type: BlendTrans1	Initial Pass/Fail: Pass	Overall Compliance: No
		Severity Score: 0.25

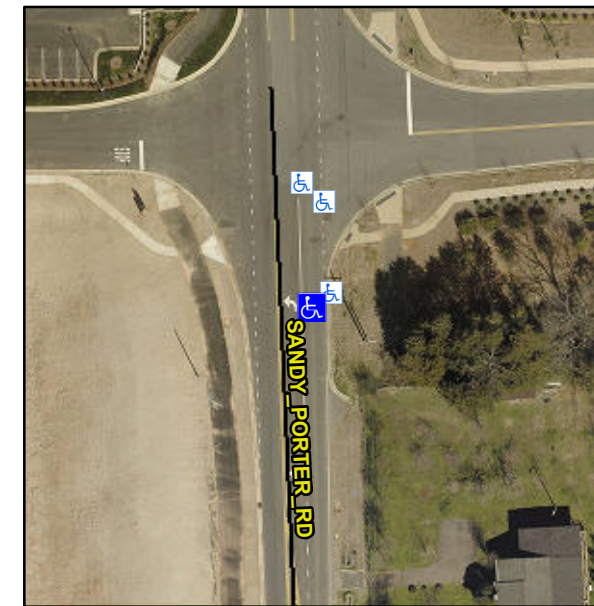
**Not Found, R304.5.3, R304.2.2-Perp, R304.3.2-Para, R305.2**

Compliance	Description	Data	Compliance	Description	Data
N/A	Ramp Length (in)	72.0	Yes	BlendTrans Slope (%)	2.4
Yes	Ramp Width (in)	60.0	No	BlendTrans XSlope (%)	3.4
N/A	Flare Type LT	Sloped	N/A	Flare Type RT	Sloped
N/A	Flare Slope LT (%)	2.8	N/A	Flare Slope RT (%)	7.2
N/A	Flare Traversable LT?	No	N/A	Flare Traversable RT?	No
Yes	Landing Length (in)	62.0	Yes	DWS Provided?	Yes
Yes	Landing Width (in)	60.0	Yes	DWS Contrast?	Yes
No	Landing Slope (%)	5.0	Yes	DWS Length (in)	24.0
Yes	Landing X Slope (%)	1.1	Yes	DWS Full Width?	Yes
N/A	Landing Curb? (Y/N)	No	No	DWS Offset (in)	3.0
N/A	Shared Landing?	No			
Yes	Gutter Ponding?	No	Yes	Gutter Slope (%)	3.2
Yes	Gutter Lip Ht (in)	0.0	Yes	Gutter X Slope (%)	2.0
N/A	Painted X Walk1?	No	N/A	Painted X Walk2?	No
	X Walk 1 Direction	To N		X Walk 2 Direction	To W
	X Walk 1 Width (in)	N/A		X Walk 2 Width (in)	N/A
	X Walk 1 Slope (%)	0.6		X Walk 2 Slope (%)	4.2
	X Walk 1 X Slope (%)	5.0		X Walk 2 X Slope (%)	1.2

N/A	Ramp inside XWalk1?	N/A	N/A	Ramp inside XWalk2?	N/A
	Road Slope (%)	1.7		Clear Space?	Yes
	Road X Slope (%)	4.2	N/A	Clear Space to XWalk (in)	N/A
Yes	Any Obstructions?	No	Yes	Storm Grate/Utility Hazard?	No
	Obstruction Type			Storm Grate/Utility Type	
		N/A			N/A
			Yes	Surface Condition? (G/P)	Good
			No	Curb Slope (%)	7.3

**Remove & Replace Curb Ramp With Two New Directional Ramps or Equivalent.**

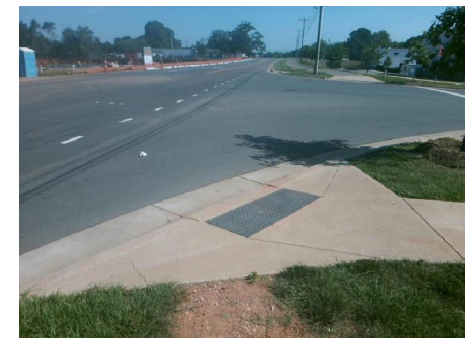
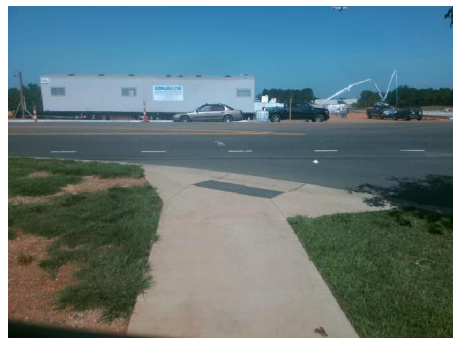
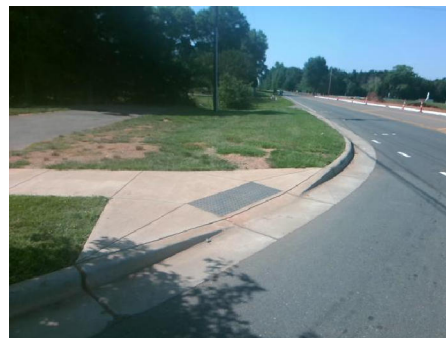
Street 1 Name SHUTTERFLY RD  
 Stop Condition-Street 1 StopSign  
 Street 2 Name SANDY PORTER RD  
 Stop Condition-Street 2 None
