# Access Compliance Report

## Public Rights-of-Way

### (Curb Ramps)

Intersection ID: 47572	Main Street: HERMSLEY_RD	Cross Street: BARRANDS_LN	Location: NW
ADA ID: 4C9E140753E7	Ramp Type: PerpDiag	Initial Pass/Fail: Fail	Overall Compliance: No
Severity Score: 8.75			
Codes/Mitigation Info/Possible Solution		Field Measurements/Component Compliance

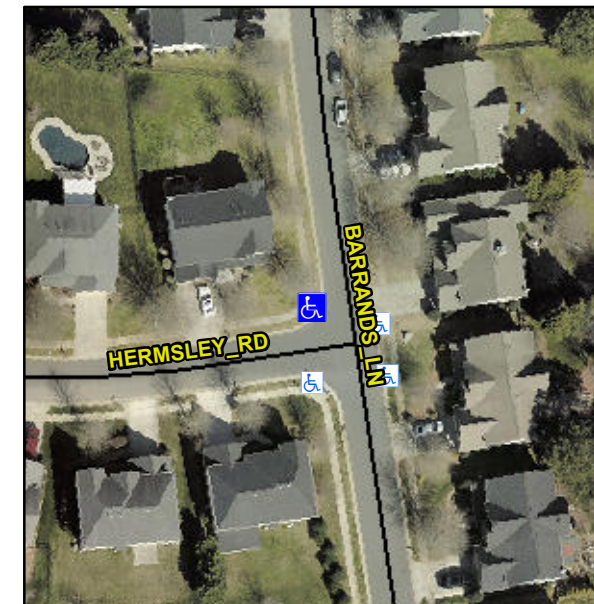
Compliance	Description	Data	Compliance	Description	Data
N/A	Ramp Length (in)	47.0	Yes	Ramp Slope (%)	6.3
No	Ramp Width (in)	44.0	Yes	Ramp XSlope (%)	0.9
N/A	Flare Type LT	N/A	N/A	Flare Type RT	N/A
N/A	Flare Slope LT (%)	N/A	N/A	Flare Slope RT (%)	N/A
N/A	Flare Traversable LT?	N/A	N/A	Flare Traversable RT?	N/A
N/A	Landing Length (in)	N/A	N/A	DWS Provided?	N/A
N/A	Landing Width (in)	N/A	N/A	DWS Contrast?	N/A
N/A	Landing Slope (%)	N/A	N/A	DWS Length (in)	N/A
N/A	Landing X Slope (%)	N/A	N/A	DWS Full Width?	N/A
N/A	Landing Curb? (Y/N)	N/A	N/A	DWS Offset (in)	N/A
N/A	Shared Landing?	N/A			
N/A	Gutter Ponding?	N/A	N/A	Gutter Slope (%)	N/A
N/A	Gutter Lip Ht (in)	N/A	N/A	Gutter X Slope (%)	N/A
N/A	Painted X Walk1?	No	N/A	Painted X Walk2?	No
	X Walk 1 Direction	To S		X Walk 2 Direction	To E
N/A	X Walk 1 Width (in)	N/A	N/A	X Walk 2 Width (in)	N/A
	X Walk 1 Slope (%)	4.8		X Walk 2 Slope (%)	4.9
	X Walk 1 X Slope (%)	2.8		X Walk 2 X Slope (%)	1.4

N/A	Ramp inside XWalk1?	N/A	N/A	Ramp inside XWalk2?	N/A
	Road Slope (%)	0.3	N/A	Clear Space?	N/A
	Road X Slope (%)	5.8	N/A	Clear Space to XWalk (in)	N/A
N/A	Any Obstructions?	N/A	N/A	Storm Grate/Utility Hazard?	N/A
	Obstruction Type			Storm Grate/Utility Type	
		N/A			N/A
			Yes	Surface Condition? (G/P)	Good

**Remove & Replace Curb Ramp With Two New Directional Ramps or Equivalent.**
