Access Compliance Report

Public Rights-of-Way

(Curb Ramps)

Intersection ID: 12671	Main Street: SEIGLE_AV	Cross Street: GREENWAY_CRESCENT_LN	Location: W
ADA ID: 4CA0A46E8BCD	Ramp Type: Directional1	Initial Pass/Fail: Fail	Overall Compliance: No
		Severity Score: 25

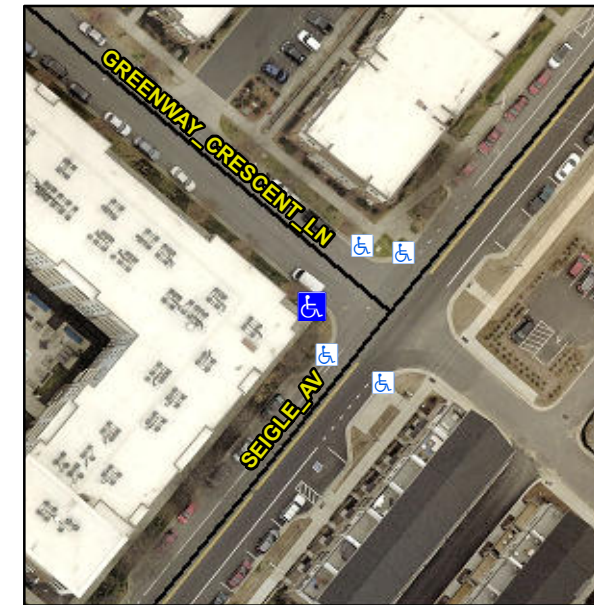
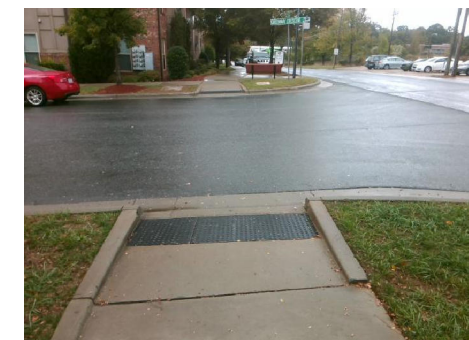
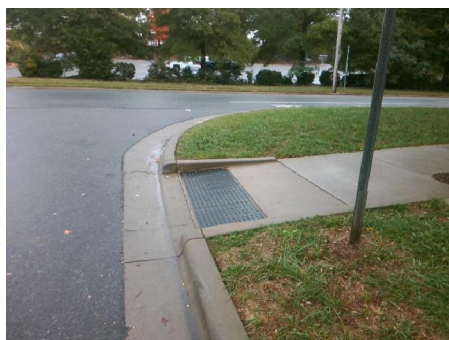
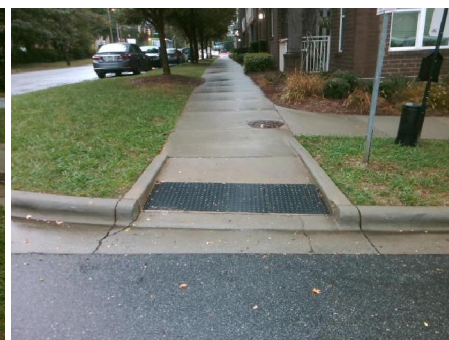
R304.2.2, R304.5.3

Compliance	Description	Data	Compliance	Description	Data
N/A	Ramp Length (in)	54.5	N/A	Grade Break?	N/A
Yes	Ramp Width (in)	68.0	N/A	Grade Break Slope (%)	0.0
No	Ramp Slope (%)	10.3	N/A	Grade Break XSlope (%)	0.0
No	Ramp XSlope (%)	5.5			
N/A	Flare Type LT	N/A	N/A	Flare Type RT	N/A
N/A	Flare Slope LT (%)	N/A	N/A	Flare Slope RT (%)	0.0
N/A	Flare Traversable LT?	N/A	N/A	Flare Traversable RT?	N/A
N/A	Landing Length (in)	0.0	N/A	DWS Provided?	N/A
N/A	Landing Width (in)	0.0	N/A	DWS Contrast?	N/A
N/A	Landing Slope (%)	0.0	N/A	DWS Length (in)	N/A
N/A	Landing X Slope (%)	0.0	N/A	DWS Full Width?	N/A
N/A	Landing Curb? (Y/N)	N/A	N/A	DWS Offset LT (in)	N/A
N/A	Shared Landing?	N/A	N/A	DWS Offset RT (in)	N/A
N/A	Gutter Ponding?	0.0	N/A	Gutter Slope (%)	N/A
N/A	Gutter Lip Ht (in)	0.0	N/A	Gutter X Slope (%)	N/A
N/A	Painted X Walk1?	No		Road Slope (%)	0.8
	X Walk 1 Direction	To NE		Road X Slope (%)	5.7
	X Walk 1 Width (in)	N/A		Clear Space?	N/A

X Walk 1 Slope (%)	0.8	N/A	Clear Space to XWalk (in)	N/A
	X Walk 1 X Slope (%)	5.7	N/A	Storm Grate/Utility Hazard?	N/A
N/A	Ramp inside XWalk1?	N/A		Storm Grate/Utility Type	
N/A	Any Obstructions?	N/A			N/A
	Obstruction Type		Yes	Surface Condition? (G/P)	Good
			N/A	Curb Slope (%)	13.6

Possible Solutions:

Remove & Replace Entire Ramp.

Total Cost: \$ 1600.00
