Access Compliance Report

Public Rights-of-Way

(Curb Ramps)

Intersection ID: 51059	Main Street: CORY-BRET_LN	Cross Street: CRAIGMOSS_LN	Location: NW
ADA ID: 4CA46EB3382F	Ramp Type: PerpDiag	Initial Pass/Fail: Fail	Overall Compliance: No
		Severity Score: 12.5

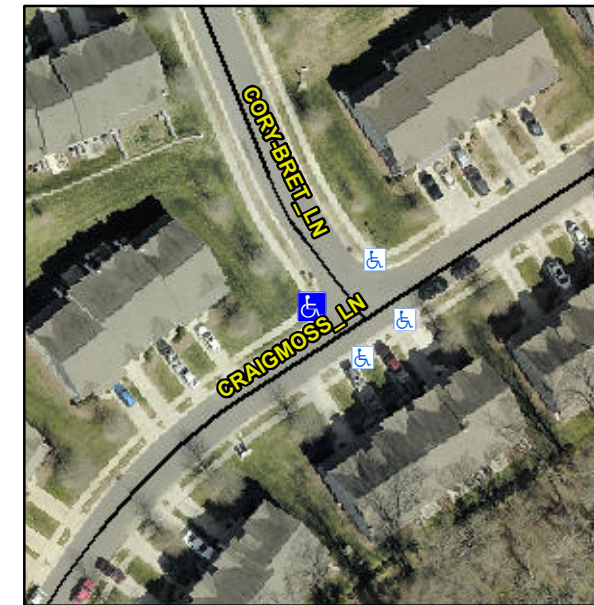
Not Found, R304.2.2

Compliance	Description	Data	Compliance	Description	Data
N/A	Ramp Length (in)	49.0	No	Ramp Slope (%)	9.2
Yes	Ramp Width (in)	48.0	Yes	Ramp XSlope (%)	2.0
N/A	Flare Type LT	N/A	N/A	Flare Type RT	N/A
N/A	Flare Slope LT (%)	N/A	N/A	Flare Slope RT (%)	N/A
N/A	Flare Traversable LT?	N/A	N/A	Flare Traversable RT?	N/A
N/A	Landing Length (in)	N/A	N/A	DWS Provided?	N/A
N/A	Landing Width (in)	N/A	N/A	DWS Contrast?	N/A
N/A	Landing Slope (%)	N/A	N/A	DWS Length (in)	N/A
N/A	Landing X Slope (%)	N/A	N/A	DWS Full Width?	N/A
N/A	Landing Curb? (Y/N)	N/A	N/A	DWS Offset (in)	N/A
N/A	Shared Landing?	N/A			
N/A	Gutter Ponding?	N/A	N/A	Gutter Slope (%)	N/A
N/A	Gutter Lip Ht (in)	N/A	N/A	Gutter X Slope (%)	N/A
N/A	Painted X Walk1?	No	N/A	Painted X Walk2?	No
	X Walk 1 Direction	To SE		X Walk 2 Direction	To NE
N/A	X Walk 1 Width (in)	N/A	N/A	X Walk 2 Width (in)	N/A
	X Walk 1 Slope (%)	0.9		X Walk 2 Slope (%)	2.6
	X Walk 1 X Slope (%)	1.8		X Walk 2 X Slope (%)	1.6

N/A	Ramp inside XWalk1?	N/A	N/A	Ramp inside XWalk2?	N/A
	Road Slope (%)	1.3	N/A	Clear Space?	N/A
	Road X Slope (%)	1.3	N/A	Clear Space to XWalk (in)	N/A
N/A	Any Obstructions?	N/A	N/A	Storm Grate/Utility Hazard?	N/A
	Obstruction Type			Storm Grate/Utility Type	
		N/A			N/A
			Yes	Surface Condition? (G/P)	Good

Possible Solutions:

Remove & Replace Curb Ramp With Two New Directional Ramps or Equivalent.
