Access Compliance Report

Public Rights-of-Way

(Curb Ramps)

Intersection ID: N/A	Main Street: GANNON_DR	Cross Street: COLLINS_FORD_RD	Location: NE
ADA ID: 4CA98DD5D8B8	Ramp Type: Perp	Initial Pass/Fail: Fail	Overall Compliance: No
		Severity Score: 1.25

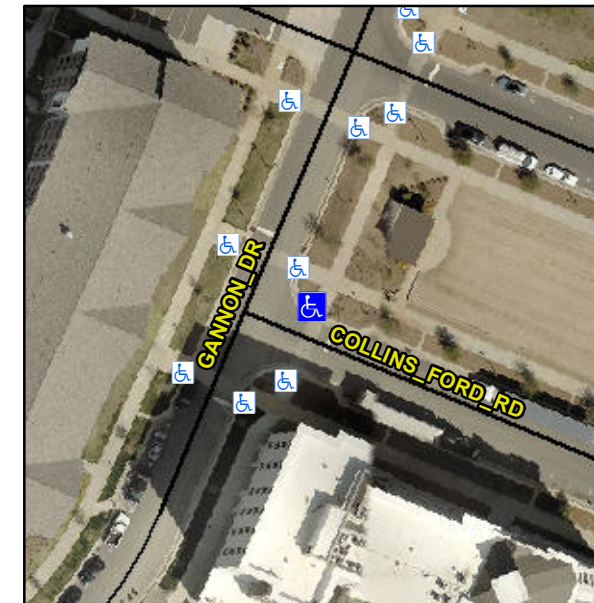
Not Found, R304.5.3

Compliance	Description	Data	Compliance	Description	Data
N/A	Ramp Length (in)	178.0	Yes	Ramp Slope (%)	5.6
Yes	Ramp Width (in)	93.0	No	Ramp XSlope (%)	2.6
N/A	Flare Type LT	N/A	N/A	Flare Type RT	N/A
N/A	Flare Slope LT (%)	N/A	N/A	Flare Slope RT (%)	N/A
N/A	Flare Traversable LT?	N/A	N/A	Flare Traversable RT?	N/A
N/A	Landing Length (in)	N/A	N/A	DWS Provided?	N/A
N/A	Landing Width (in)	N/A	N/A	DWS Contrast?	N/A
N/A	Landing Slope (%)	N/A	N/A	DWS Length (in)	N/A
N/A	Landing X Slope (%)	N/A	N/A	DWS Full Width?	N/A
N/A	Landing Curb? (Y/N)	N/A	N/A	DWS Offset (in)	N/A
N/A	Shared Landing?	N/A			
N/A	Gutter Ponding?	N/A	N/A	Gutter Slope (%)	N/A
N/A	Gutter Lip Ht (in)	N/A	N/A	Gutter X Slope (%)	N/A
N/A	Painted X Walk1?	Yes	N/A	Painted X Walk2?	N/A
	X Walk 1 Direction	To SW		X Walk 2 Direction	N/A
N/A	X Walk 1 Width (in)	97.5	N/A	X Walk 2 Width (in)	N/A
	X Walk 1 Slope (%)	3.2		X Walk 2 Slope (%)	N/A
	X Walk 1 X Slope (%)	1.3		X Walk 2 X Slope (%)	N/A

N/A	Ramp inside XWalk1?	Yes	N/A	Ramp inside XWalk2?	N/A
	Road Slope (%)	N/A	N/A	Clear Space?	N/A
	Road X Slope (%)	N/A	N/A	Clear Space to XWalk (in)	N/A
N/A	Any Obstructions?	N/A	N/A	Storm Grate/Utility Hazard?	N/A
	Obstruction Type			Storm Grate/Utility Type	
		N/A			N/A
			Yes	Surface Condition? (G/P)	Good

Remove & Replace Entire Ramp.
