Access Compliance Report

Public Rights-of-Way

(Curb Ramps)

Intersection ID: 50617	Main Street: GOLDEN_WOOD_LN	Cross Street: PADDLE_OAK_RD	Location: NW
ADA ID: 4CB6720B6083	Ramp Type: Perp	Initial Pass/Fail: Fail	Overall Compliance: No
		Severity Score: 12.5

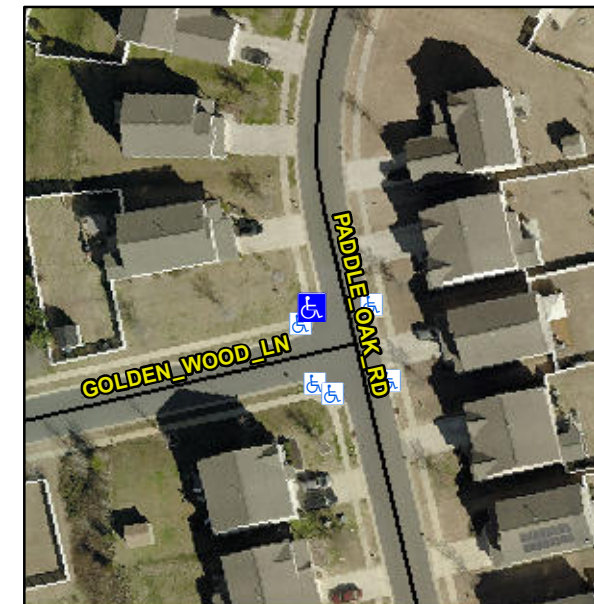
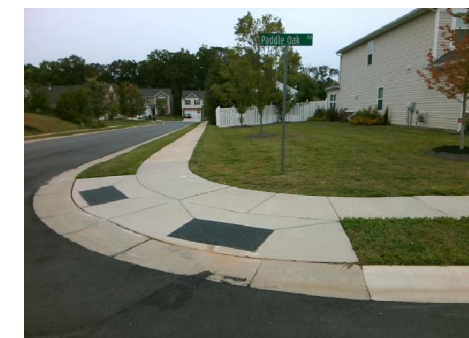
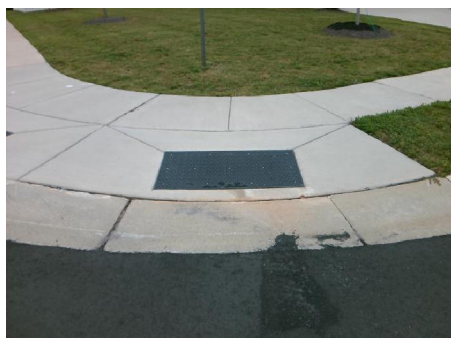
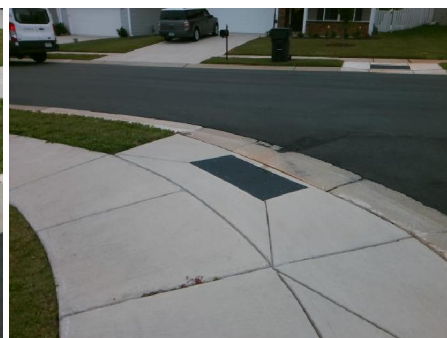
Compliance	Description	Data	Compliance	Description	Data
N/A	Ramp Length (in)	48.0	No	Ramp Slope (%)	10.6
Yes	Ramp Width (in)	48.0	Yes	Ramp XSlope (%)	1.1
N/A	Flare Type LT	N/A	N/A	Flare Type RT	N/A
N/A	Flare Slope LT (%)	N/A	N/A	Flare Slope RT (%)	N/A
N/A	Flare Traversable LT?	N/A	N/A	Flare Traversable RT?	N/A
N/A	Landing Length (in)	N/A	N/A	DWS Provided?	N/A
N/A	Landing Width (in)	N/A	N/A	DWS Contrast?	N/A
N/A	Landing Slope (%)	N/A	N/A	DWS Length (in)	N/A
N/A	Landing X Slope (%)	N/A	N/A	DWS Full Width?	N/A
N/A	Landing Curb? (Y/N)	N/A	N/A	DWS Offset (in)	N/A
N/A	Shared Landing?	N/A			
N/A	Gutter Ponding?	N/A	N/A	Gutter Slope (%)	N/A
N/A	Gutter Lip Ht (in)	N/A	N/A	Gutter X Slope (%)	N/A
N/A	Painted X Walk1?	No	N/A	Painted X Walk2?	N/A
	X Walk 1 Direction	To E		X Walk 2 Direction	N/A
N/A	X Walk 1 Width (in)	N/A	N/A	X Walk 2 Width (in)	N/A
	X Walk 1 Slope (%)	2.3		X Walk 2 Slope (%)	N/A
	X Walk 1 X Slope (%)	3.0		X Walk 2 X Slope (%)	N/A

N/A	Ramp inside XWalk1?	N/A	N/A	Ramp inside XWalk2?	N/A
	Road Slope (%)	N/A	N/A	Clear Space?	N/A
	Road X Slope (%)	N/A	N/A	Clear Space to XWalk (in)	N/A
N/A	Any Obstructions?	N/A	N/A	Storm Grate/Utility Hazard?	N/A
	Obstruction Type			Storm Grate/Utility Type	
		N/A			N/A
			Yes	Surface Condition? (G/P)	Good

Possible Solutions:

Remove & Replace Entire Ramp.

R304.2.2
