Access Compliance Report

Public Rights-of-Way

(Curb Ramps)

Intersection ID: 48451	Main Street: RED_RUST_LN	Cross Street: DANCING_WIND_RD	Location: NW
ADA ID: 4CBBB0A21765	Ramp Type: Perp	Initial Pass/Fail: Fail	Overall Compliance: No
Severity Score: 10			
Codes/Mitigation Info/Possible Solution		Field Measurements/Component Compliance

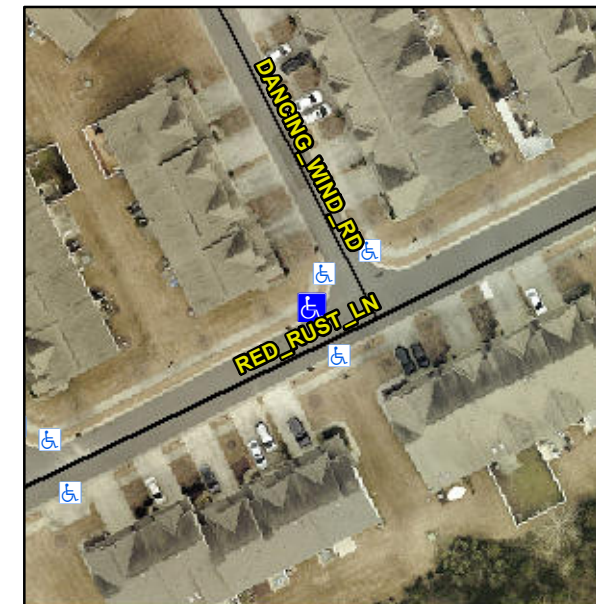
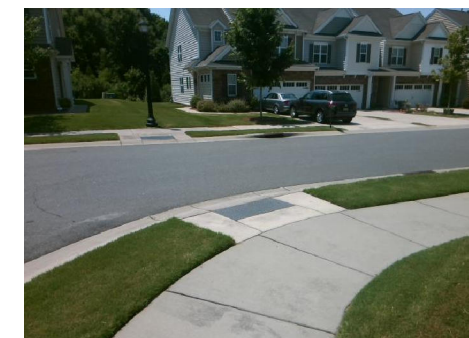
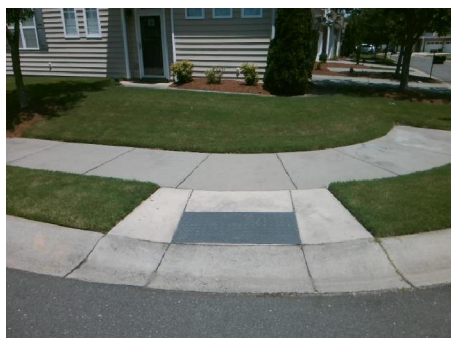
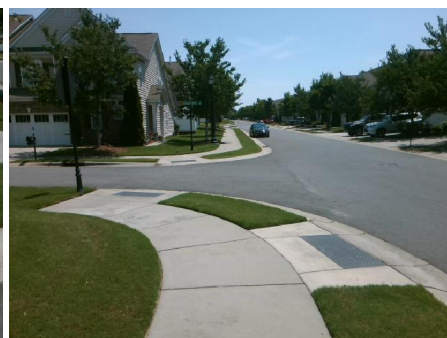
Not Found, R304.5.1, R304.5.3

Compliance	Description	Data	Compliance	Description	Data
N/A	Ramp Length (in)	47.0	Yes	Ramp Slope (%)	5.4
No	Ramp Width (in)	46.5	No	Ramp XSlope (%)	3.0
N/A	Flare Type LT	N/A	N/A	Flare Type RT	N/A
N/A	Flare Slope LT (%)	N/A	N/A	Flare Slope RT (%)	N/A
N/A	Flare Traversable LT?	N/A	N/A	Flare Traversable RT?	N/A
N/A	Landing Length (in)	N/A	N/A	DWS Provided?	N/A
N/A	Landing Width (in)	N/A	N/A	DWS Contrast?	N/A
N/A	Landing Slope (%)	N/A	N/A	DWS Length (in)	N/A
N/A	Landing X Slope (%)	N/A	N/A	DWS Full Width?	N/A
N/A	Landing Curb? (Y/N)	N/A	N/A	DWS Offset (in)	N/A
N/A	Shared Landing?	N/A			
N/A	Gutter Ponding?	N/A	N/A	Gutter Slope (%)	N/A
N/A	Gutter Lip Ht (in)	N/A	N/A	Gutter X Slope (%)	N/A
N/A	Painted X Walk1?	No	N/A	Painted X Walk2?	N/A
	X Walk 1 Direction	To SE		X Walk 2 Direction	N/A
N/A	X Walk 1 Width (in)	N/A	N/A	X Walk 2 Width (in)	N/A
	X Walk 1 Slope (%)	2.7		X Walk 2 Slope (%)	N/A
	X Walk 1 X Slope (%)	0.4		X Walk 2 X Slope (%)	N/A

N/A	Ramp inside XWalk1?	N/A	N/A	Ramp inside XWalk2?	N/A
	Road Slope (%)	N/A	N/A	Clear Space?	N/A
	Road X Slope (%)	N/A	N/A	Clear Space to XWalk (in)	N/A
N/A	Any Obstructions?	N/A	N/A	Storm Grate/Utility Hazard?	N/A
	Obstruction Type			Storm Grate/Utility Type	
		N/A			N/A
			Yes	Surface Condition? (G/P)	Good

Possible Solutions:

Remove & Replace Entire Ramp.
