# Access Compliance Report

## Public Rights-of-Way

### (Curb Ramps)

Intersection ID: 2490	Main Street: BENTGRASS_RUN_DR	Cross Street: LYLETON_LN	Location: E
ADA ID: 4CDBF23A7BBC	Ramp Type: PerpDiag	Initial Pass/Fail: Pass	Overall Compliance: No
		Severity Score: 15

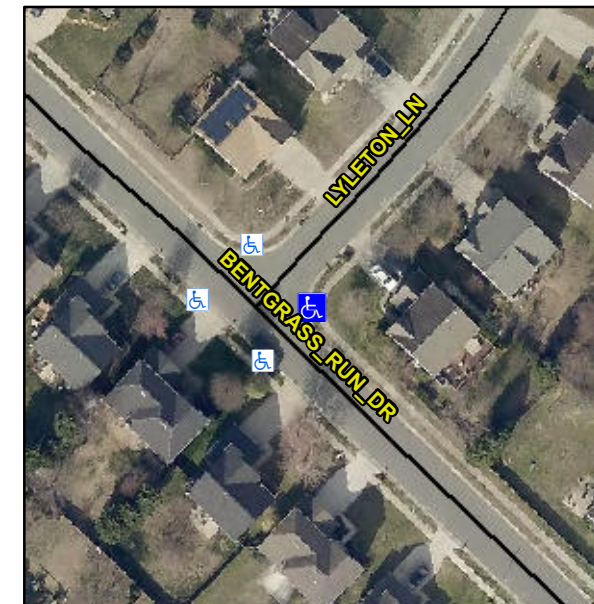
**Not Found, R304.2.1, R304.2.2-Perp, R304.3.2-Para, R305, R304.5.4**

Compliance	Description	Data	Compliance	Description	Data
N/A	Ramp Length (in)	49.0	Yes	Ramp Slope (%)	5.9
Yes	Ramp Width (in)	108.0	Yes	Ramp XSlope (%)	0.8
N/A	Flare Type LT	Sloped	N/A	Flare Type RT	N/A
N/A	Flare Slope LT (%)	6.6	Yes	Flare Slope RT (%)	4.0
N/A	Flare Traversable LT?	Yes	N/A	Flare Traversable RT?	Yes
No	Landing Length (in)	46.0	No	DWS Provided?	No
Yes	Landing Width (in)	85.0	N/A	DWS Contrast?	No
No	Landing Slope (%)	2.3	N/A	DWS Length (in)	N/A
Yes	Landing X Slope (%)	0.3	N/A	DWS Full Width?	No
N/A	Landing Curb? (Y/N)	No	N/A	DWS Offset (in)	N/A
N/A	Shared Landing?	No			
Yes	Gutter Ponding?	No	No	Gutter Slope (%)	5.6
Yes	Gutter Lip Ht (in)	0.0	Yes	Gutter X Slope (%)	2.0
N/A	Painted X Walk1?	No	N/A	Painted X Walk2?	No
	X Walk 1 Direction	To NW		X Walk 2 Direction	To SW
N/A	X Walk 1 Width (in)	N/A	N/A	X Walk 2 Width (in)	N/A
	X Walk 1 Slope (%)	0.6		X Walk 2 Slope (%)	2.0
	X Walk 1 X Slope (%)	3.1		X Walk 2 X Slope (%)	1.8

N/A	Ramp inside XWalk1?	N/A	N/A	Ramp inside XWalk2?	N/A
	Road Slope (%)	1.4	N/A	Clear Space?	Yes
	Road X Slope (%)	2.2	N/A	Clear Space to XWalk (in)	N/A
Yes	Any Obstructions?	No	Yes	Storm Grate/Utility Hazard?	No
	Obstruction Type			Storm Grate/Utility Type	
		N/A			N/A
			Yes	Surface Condition? (G/P)	Good

**Remove & Replace Curb Ramp With Two New Directional Ramps or Equivalent. Remove & Replace Gutter.**

Total Cost: \$ 3950.00
