Access Compliance Report

Public Rights-of-Way

(Curb Ramps)

Intersection ID: 13082	Main Street: DEARMON_DR	Cross Street: ROLAND_ST	Location: NW
ADA ID: 4CDF2750E5B5	Ramp Type: Perp	Initial Pass/Fail: Fail	Overall Compliance: No
Severity Score: 21.25			
Codes/Mitigation Info/Possible Solution		Field Measurements/Component Compliance

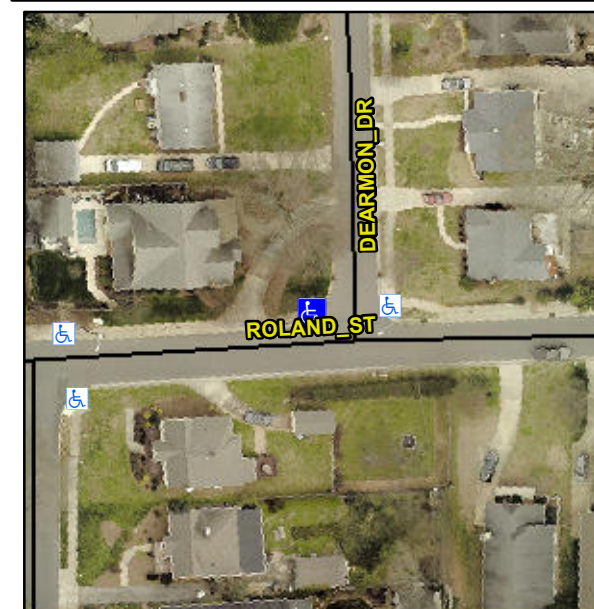
R304.5.1, R304.2.2

Compliance	Description	Data	Compliance	Description	Data
N/A	Ramp Length (in)	72.0	No	Ramp Slope (%)	8.9
No	Ramp Width (in)	47.5	Yes	Ramp XSlope (%)	1.8
N/A	Flare Type LT	N/A	N/A	Flare Type RT	N/A
N/A	Flare Slope LT (%)	N/A	N/A	Flare Slope RT (%)	N/A
N/A	Flare Traversable LT?	N/A	N/A	Flare Traversable RT?	N/A
N/A	Landing Length (in)	N/A	N/A	DWS Provided?	N/A
N/A	Landing Width (in)	N/A	N/A	DWS Contrast?	N/A
N/A	Landing Slope (%)	N/A	N/A	DWS Length (in)	N/A
N/A	Landing X Slope (%)	N/A	N/A	DWS Full Width?	N/A
N/A	Landing Curb? (Y/N)	N/A	N/A	DWS Offset (in)	N/A
N/A	Shared Landing?	N/A			
N/A	Gutter Ponding?	N/A	N/A	Gutter Slope (%)	N/A
N/A	Gutter Lip Ht (in)	N/A	N/A	Gutter X Slope (%)	N/A
N/A	Painted X Walk1?	No	N/A	Painted X Walk2?	N/A
	X Walk 1 Direction	To E		X Walk 2 Direction	N/A
N/A	X Walk 1 Width (in)	N/A	N/A	X Walk 2 Width (in)	N/A
	X Walk 1 Slope (%)	2.2		X Walk 2 Slope (%)	N/A
	X Walk 1 X Slope (%)	0.6		X Walk 2 X Slope (%)	N/A

N/A	Ramp inside XWalk1?	N/A	N/A	Ramp inside XWalk2?	N/A
	Road Slope (%)	N/A	N/A	Clear Space?	N/A
	Road X Slope (%)	N/A	N/A	Clear Space to XWalk (in)	N/A
N/A	Any Obstructions?	N/A	N/A	Storm Grate/Utility Hazard?	N/A
	Obstruction Type			Storm Grate/Utility Type	
		N/A			N/A
			Yes	Surface Condition? (G/P)	Good

Possible Solutions:

Remove & Replace Entire Ramp.
