Access Compliance Report

Public Rights-of-Way

(Curb Ramps)

Intersection ID: 12636	Main Street: BENTLEY_PL	Cross Street: EASTWAY_DR	Location: SW
ADA ID: 4CEBBA8EF8F0	Ramp Type: Perp	Initial Pass/Fail: Fail	Overall Compliance: No
Severity Score: 13.75			
Codes/Mitigation Info/Possible Solution		Field Measurements/Component Compliance

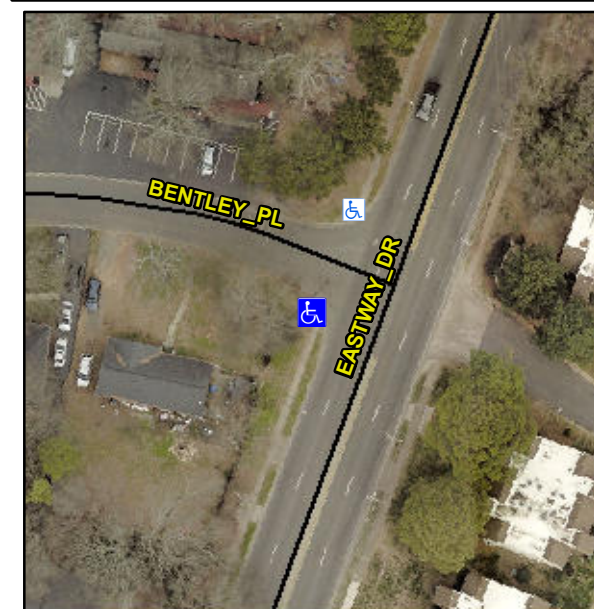
Not Found, R304.2.2, R304.5.3

Compliance	Description	Data	Compliance	Description	Data
N/A	Ramp Length (in)	48.0	No	Ramp Slope (%)	10.7
Yes	Ramp Width (in)	48.0	No	Ramp XSlope (%)	2.2
N/A	Flare Type LT	N/A	N/A	Flare Type RT	N/A
N/A	Flare Slope LT (%)	N/A	N/A	Flare Slope RT (%)	N/A
N/A	Flare Traversable LT?	N/A	N/A	Flare Traversable RT?	N/A
N/A	Landing Length (in)	N/A	N/A	DWS Provided?	N/A
N/A	Landing Width (in)	N/A	N/A	DWS Contrast?	N/A
N/A	Landing Slope (%)	N/A	N/A	DWS Length (in)	N/A
N/A	Landing X Slope (%)	N/A	N/A	DWS Full Width?	N/A
N/A	Landing Curb? (Y/N)	N/A	N/A	DWS Offset (in)	N/A
N/A	Shared Landing?	N/A			
N/A	Gutter Ponding?	Yes	N/A	Gutter Slope (%)	N/A
N/A	Gutter Lip Ht (in)	N/A	N/A	Gutter X Slope (%)	N/A
N/A	Painted X Walk1?	No	N/A	Painted X Walk2?	N/A
	X Walk 1 Direction	To NE		X Walk 2 Direction	N/A
N/A	X Walk 1 Width (in)	N/A	N/A	X Walk 2 Width (in)	N/A
	X Walk 1 Slope (%)	2.0		X Walk 2 Slope (%)	N/A
	X Walk 1 X Slope (%)	2.3		X Walk 2 X Slope (%)	N/A

N/A	Ramp inside XWalk1?	N/A	N/A	Ramp inside XWalk2?	N/A
	Road Slope (%)	N/A	N/A	Clear Space?	N/A
	Road X Slope (%)	N/A	N/A	Clear Space to XWalk (in)	N/A
N/A	Any Obstructions?	N/A	N/A	Storm Grate/Utility Hazard?	N/A
	Obstruction Type			Storm Grate/Utility Type	
		N/A			N/A
			Yes	Surface Condition? (G/P)	Good

Remove & Replace Entire Ramp.
