# Access Compliance Report

## Public Rights-of-Way

### (Curb Ramps)

Intersection ID: 12051	Main Street: LUMINA_AV	Cross Street: MARLOWE_AV	Location: SW
ADA ID: 4CEECEB2E2FF	Ramp Type: BlendTrans2	Initial Pass/Fail: Fail	Overall Compliance: No
		Severity Score: 10

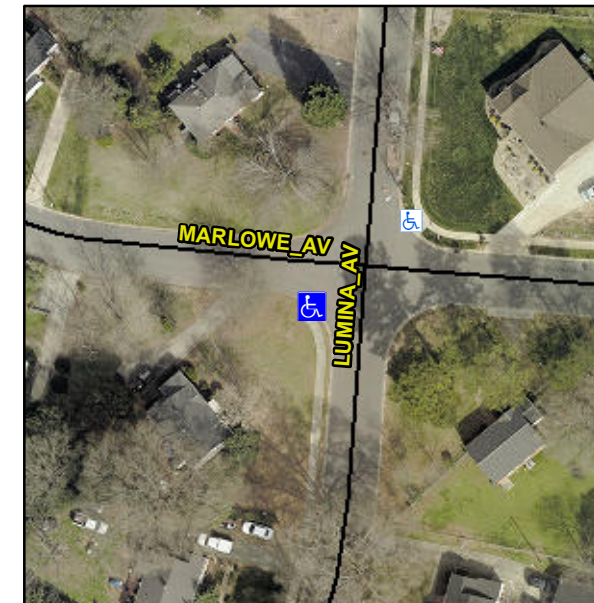
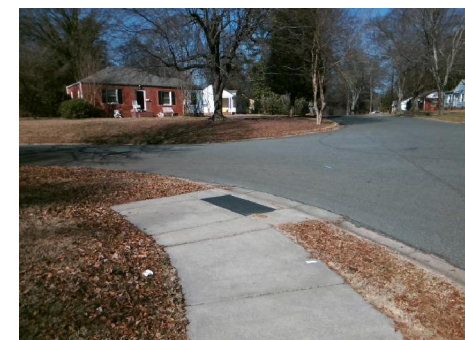
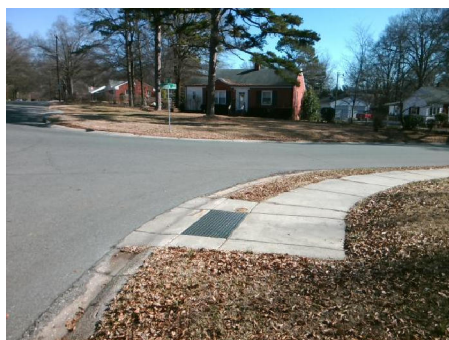
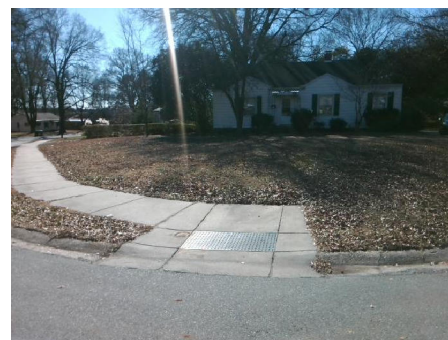
**Not Found, R304.5.1, R304.5.3**

Compliance	Description	Data	Compliance	Description	Data
N/A	Ramp Length (in)	82.0	Yes	BlendTrans Slope (%)	2.2
No	Ramp Width (in)	47.5	No	BlendTrans XSlope (%)	2.7
N/A	Flare Type LT	N/A	N/A	Flare Type RT	N/A
N/A	Flare Slope LT (%)	N/A	N/A	Flare Slope RT (%)	N/A
N/A	Flare Traversable LT?	N/A	N/A	Flare Traversable RT?	N/A
N/A	Landing Length (in)	N/A	N/A	DWS Provided?	N/A
N/A	Landing Width (in)	N/A	N/A	DWS Contrast?	N/A
N/A	Landing Slope (%)	N/A	N/A	DWS Length (in)	N/A
N/A	Landing X Slope (%)	N/A	N/A	DWS Full Width?	N/A
N/A	Landing Curb? (Y/N)	N/A	N/A	DWS Offset (in)	N/A
N/A	Shared Landing?	N/A			
N/A	Gutter Ponding?	N/A	N/A	Gutter Slope (%)	N/A
N/A	Gutter Lip Ht (in)	N/A	N/A	Gutter X Slope (%)	N/A
N/A	Painted X Walk1?	No	N/A	Painted X Walk2?	N/A
	X Walk 1 Direction	To NE		X Walk 2 Direction	N/A
	X Walk 1 Width (in)	N/A		X Walk 2 Width (in)	N/A
	X Walk 1 Slope (%)	7.9		X Walk 2 Slope (%)	N/A
	X Walk 1 X Slope (%)	2.5		X Walk 2 X Slope (%)	N/A

N/A	Ramp inside XWalk1?	N/A	N/A	Ramp inside XWalk2?	N/A
	Road Slope (%)	2.5		Clear Space?	N/A
	Road X Slope (%)	7.9	N/A	Clear Space to XWalk (in)	N/A
N/A	Any Obstructions?	N/A	N/A	Storm Grate/Utility Hazard?	N/A
	Obstruction Type			Storm Grate/Utility Type	
		N/A			N/A
			Yes	Surface Condition? (G/P)	Good
			No	Curb Slope (%)	7.1

**Remove & Replace Curb Ramp With Two New Directional Ramps or Equivalent.**
