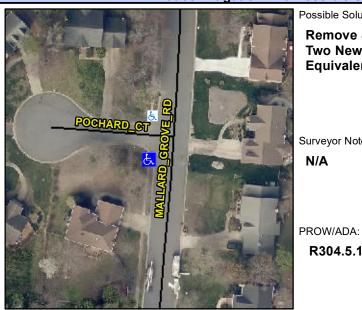
3200.00

Field Measurements/Component Compliance						
	Compliance Description		Data	Comp	liance Description	Data
	N/A	Ramp Length (in)	62.0	Yes	BlendTrans Slope (%)	2.1
	No	Ramp Width (in)	45.0	No	BlendTrans XSlope (%)	3.1
	N/A	Flare Type LT	N/A	N/A	Flare Type RT	N/A
	N/A	Flare Slope LT (%)	N/A	N/A	Flare Slope RT (%)	N/A
	N/A	Flare Traversable LT?	N/A	N/A	Flare Traversable RT?	N/A
	N/A	Landing Length (in)	N/A	N/A	DWS Provided?	N/A
	N/A	Landing Width (in)	N/A	N/A	DWS Contrast?	N/A
	N/A	Landing Slope (%)	N/A	N/A	DWS Length (in)	N/A
	N/A	Landing X Slope (%)	N/A	N/A	DWS Full Width?	N/A
	N/A	Landing Curb? (Y/N)	N/A	N/A	DWS Offset (in)	N/A
	N/A	Shared Landing?	N/A			
	N/A	Gutter Ponding?	N/A	N/A	Gutter Slope (%)	N/A
	N/A	Gutter Lip Ht (in)	N/A	N/A	Gutter X Slope (%)	N/A
	N/A	Painted X Walk1?	No	N/A	Painted X Walk2?	N/A
		X Walk 1 Direction	To N		X Walk 2 Direction	N/A
		X Walk 1 Width (in)	N/A		X Walk 2 Width (in)	N/A
		X Walk 1 Slope (%)	5.2		X Walk 2 Slope (%)	N/A

Possible Solutions:
