# Access Compliance Report

## Public Rights-of-Way

### (Curb Ramps)

| Intersection ID: 49928 | Main Street: PAXTON_RUN_RD | Cross Street: CAMPBELL_HALL_CT | Location: SE |

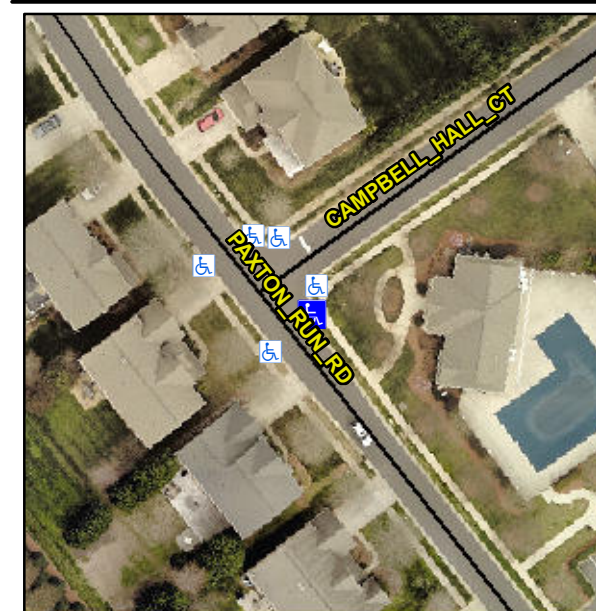
| ADA ID: 4D03A4EF9BA4 | Ramp Type: Perp | Initial Pass/Fail: Fail | Overall Compliance: No |

**Not Found, R304.5.1**

| Compliance | Description | Data | Compliance | Description | Data |
|---|---|---|---|---|---|
| N/A | Ramp Length (in) | 47.0 | Yes | Ramp Slope (%) | 5.2 |
| No | Ramp Width (in) | 45.0 | Yes | Ramp XSlope (%) | 2.5 |

**Remove & Replace Entire Ramp.**

Total Cost: \$ 1850.00
