Access Compliance Report

Public Rights-of-Way

(Curb Ramps)

Intersection ID: 5055	Main Street: GRABILL_DR	Cross Street: MASON_DR	Location: NW
ADA ID: 4D09764749E1	Ramp Type: Perp	Initial Pass/Fail: Fail	Overall Compliance: No
Severity Score: 33.75			
Codes/Mitigation Info/Possible Solution		Field Measurements/Component Compliance

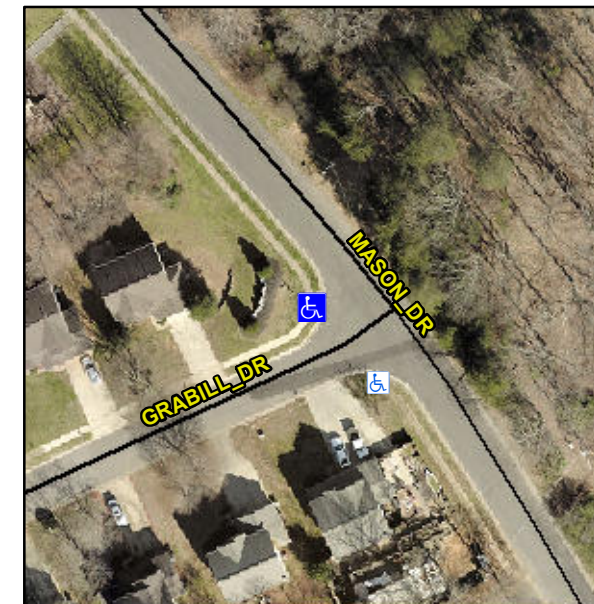
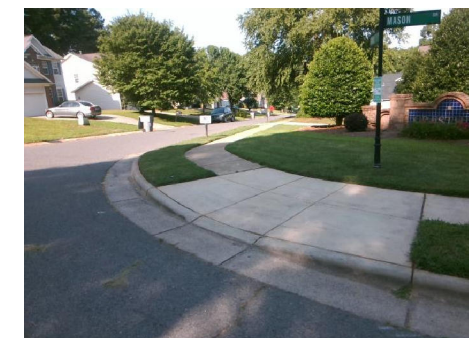
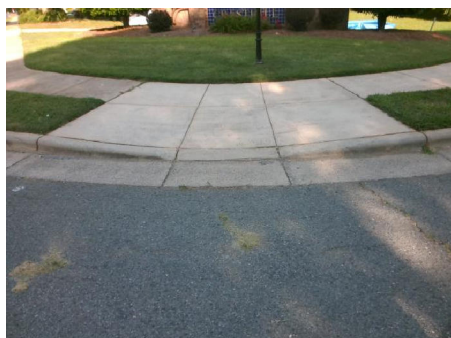
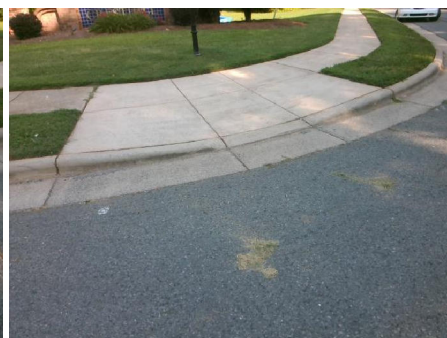
Not Found, R304.5.1, R304.2.2

Compliance	Description	Data	Compliance	Description	Data
N/A	Ramp Length (in)	52.0	No	Ramp Slope (%)	20.0
No	Ramp Width (in)	46.0	Yes	Ramp XSlope (%)	1.4
N/A	Flare Type LT	N/A	N/A	Flare Type RT	N/A
N/A	Flare Slope LT (%)	N/A	N/A	Flare Slope RT (%)	N/A
N/A	Flare Traversable LT?	N/A	N/A	Flare Traversable RT?	N/A
N/A	Landing Length (in)	N/A	N/A	DWS Provided?	N/A
N/A	Landing Width (in)	N/A	N/A	DWS Contrast?	N/A
N/A	Landing Slope (%)	N/A	N/A	DWS Length (in)	N/A
N/A	Landing X Slope (%)	N/A	N/A	DWS Full Width?	N/A
N/A	Landing Curb? (Y/N)	N/A	N/A	DWS Offset (in)	N/A
N/A	Shared Landing?	N/A			
N/A	Gutter Ponding?	N/A	N/A	Gutter Slope (%)	N/A
N/A	Gutter Lip Ht (in)	N/A	N/A	Gutter X Slope (%)	N/A
N/A	Painted X Walk1?	No	N/A	Painted X Walk2?	N/A
	X Walk 1 Direction	To SE		X Walk 2 Direction	N/A
N/A	X Walk 1 Width (in)	N/A	N/A	X Walk 2 Width (in)	N/A
	X Walk 1 Slope (%)	1.9		X Walk 2 Slope (%)	N/A
	X Walk 1 X Slope (%)	2.4		X Walk 2 X Slope (%)	N/A

N/A	Ramp inside XWalk1?	N/A	N/A	Ramp inside XWalk2?	N/A
	Road Slope (%)	N/A	N/A	Clear Space?	N/A
	Road X Slope (%)	N/A	N/A	Clear Space to XWalk (in)	N/A
N/A	Any Obstructions?	N/A	N/A	Storm Grate/Utility Hazard?	N/A
	Obstruction Type			Storm Grate/Utility Type	
		N/A			N/A
			Yes	Surface Condition? (G/P)	Good

Remove & Replace Entire Ramp.
