Access Compliance Report

Public Rights-of-Way

(Curb Ramps)

Intersection ID: 10042462	Main Street: YORKMONT_RD	Cross Street: N/A	Location: NE
ADA ID: 4D0CC797399E	Ramp Type: BlendTrans1	Initial Pass/Fail: Pass	Overall Compliance: No
Severity Score: 0			
Codes/Mitigation Info/Possible Solution		Field Measurements/Component Compliance

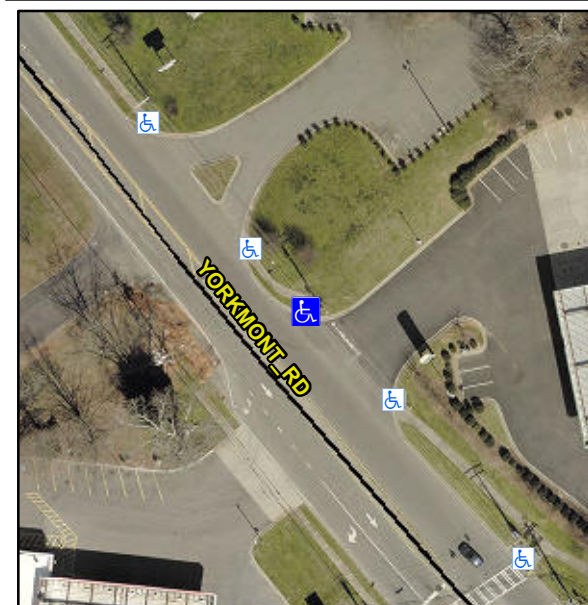
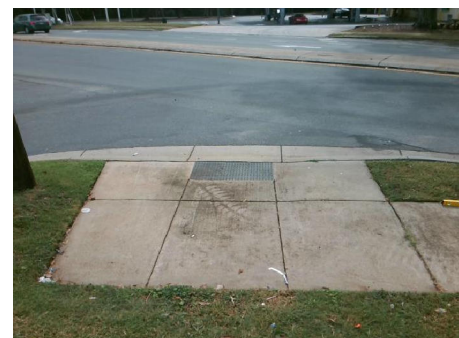
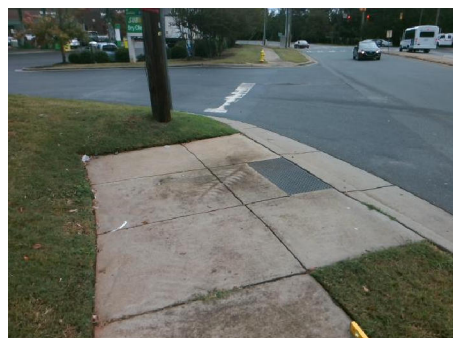
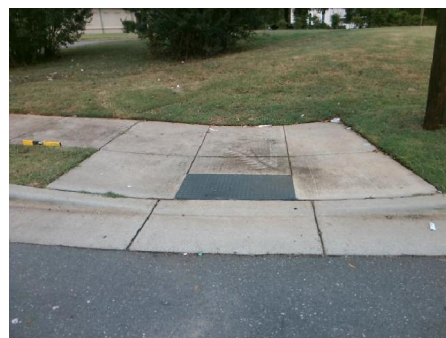
Compliance	Description	Data	Compliance	Description	Data
N/A	Ramp Length (in)	48.0	Yes	BlendTrans Slope (%)	0.9
Yes	Ramp Width (in)	48.0	Yes	BlendTrans XSlope (%)	0.5
N/A	Flare Type LT	Sloped	N/A	Flare Type RT	Sloped
N/A	Flare Slope LT (%)	4.2	N/A	Flare Slope RT (%)	2.0
N/A	Flare Traversable LT?	No	N/A	Flare Traversable RT?	No
Yes	Landing Length (in)	59.0	Yes	DWS Provided?	Yes
Yes	Landing Width (in)	48.0	Yes	DWS Contrast?	Yes
Yes	Landing Slope (%)	0.6	Yes	DWS Length (in)	24.0
Yes	Landing X Slope (%)	0.3	Yes	DWS Full Width?	Yes
N/A	Landing Curb? (Y/N)	No	Yes	DWS Offset (in)	1.0
N/A	Shared Landing?	No			
Yes	Gutter Ponding?	No	Yes	Gutter Slope (%)	0.7
Yes	Gutter Lip Ht (in)	0.0	Yes	Gutter X Slope (%)	1.1
N/A	Painted X Walk1?	No	N/A	Painted X Walk2?	No
	X Walk 1 Direction	To SW		X Walk 2 Direction	To SE
	X Walk 1 Width (in)	N/A		X Walk 2 Width (in)	N/A
	X Walk 1 Slope (%)	0.6		X Walk 2 Slope (%)	1.2
	X Walk 1 X Slope (%)	0.9		X Walk 2 X Slope (%)	0.9

N/A	Ramp inside XWalk1?	N/A	N/A	Ramp inside XWalk2?	N/A
	Road Slope (%)	0.2		Clear Space?	Yes
	Road X Slope (%)	1.9	N/A	Clear Space to XWalk (in)	N/A
Yes	Any Obstructions?	No	Yes	Storm Grate/Utility Hazard?	No
	Obstruction Type			Storm Grate/Utility Type	
		N/A			N/A
			Yes	Surface Condition? (G/P)	Good
			No	Curb Slope (%)	7.0

Possible Solutions:

Remove & Replace Curb Slope and Extend Ramp.
