Access Compliance Report

Public Rights-of-Way

(Curb Ramps)

Intersection ID: 10012737	Main Street: WARP_ST	Cross Street: N/A	Location:	N
ADA ID: 4D0CD200AE39	Ramp Type: Perp	Initial Pass/Fail: Fail	Overall Compliance: No	Severity Score: 8.75
Codes/Mitigation Info/Possible Solution		Field Measurements/Component Compliance

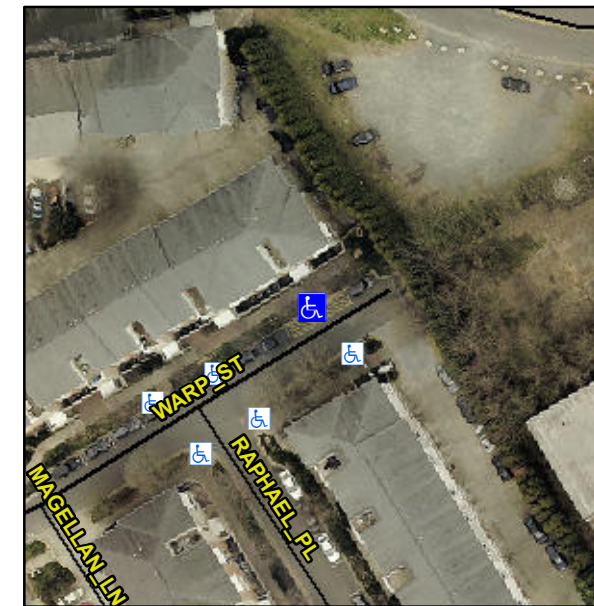
Not Found, R304.5.1

Compliance	Description	Data	Compliance	Description	Data
N/A	Ramp Length (in)	96.0	Yes	Ramp Slope (%)	7.6
No	Ramp Width (in)	47.0	Yes	Ramp XSlope (%)	1.4
N/A	Flare Type LT	N/A	N/A	Flare Type RT	N/A
N/A	Flare Slope LT (%)	N/A	N/A	Flare Slope RT (%)	N/A
N/A	Flare Traversable LT?	N/A	N/A	Flare Traversable RT?	N/A
N/A	Landing Length (in)	N/A	N/A	DWS Provided?	N/A
N/A	Landing Width (in)	N/A	N/A	DWS Contrast?	N/A
N/A	Landing Slope (%)	N/A	N/A	DWS Length (in)	N/A
N/A	Landing X Slope (%)	N/A	N/A	DWS Full Width?	N/A
N/A	Landing Curb? (Y/N)	N/A	N/A	DWS Offset (in)	N/A
N/A	Shared Landing?	N/A			
N/A	Gutter Ponding?	N/A	N/A	Gutter Slope (%)	N/A
N/A	Gutter Lip Ht (in)	N/A	N/A	Gutter X Slope (%)	N/A
N/A	Painted X Walk1?	No	N/A	Painted X Walk2?	N/A
	X Walk 1 Direction	To SE		X Walk 2 Direction	N/A
N/A	X Walk 1 Width (in)	N/A	N/A	X Walk 2 Width (in)	N/A
	X Walk 1 Slope (%)	1.5		X Walk 2 Slope (%)	N/A
	X Walk 1 X Slope (%)	1.3		X Walk 2 X Slope (%)	N/A

N/A	Ramp inside XWalk1?	N/A	N/A	Ramp inside XWalk2?	N/A
	Road Slope (%)	N/A	N/A	Clear Space?	N/A
	Road X Slope (%)	N/A	N/A	Clear Space to XWalk (in)	N/A
N/A	Any Obstructions?	N/A	N/A	Storm Grate/Utility Hazard?	N/A
	Obstruction Type			Storm Grate/Utility Type	
		N/A			N/A
			Yes	Surface Condition? (G/P)	Good

Remove & Replace Entire Ramp.

Total Cost: \$ 1850.00
