Access Compliance Report

Public Rights-of-Way

(Curb Ramps)

| Intersection ID: 19926 | Main Street: ARCHDALE_DR | Cross Street: FERNHILL_DR | Location: SE |

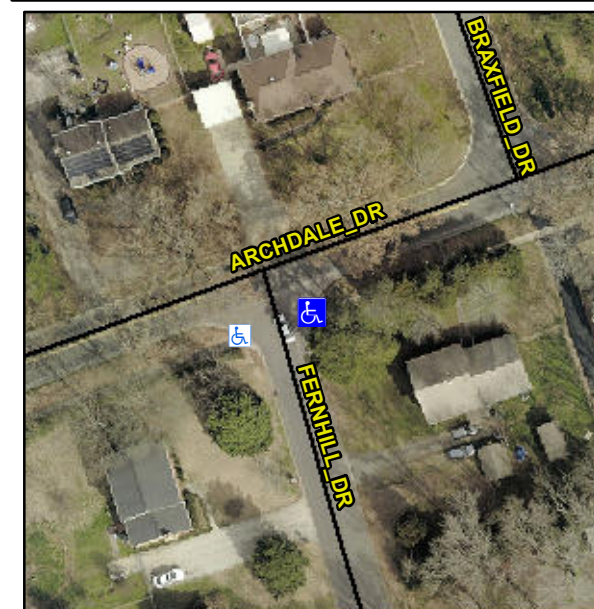
| ADA ID: 4D0E3334142E | Ramp Type: PerpDiag | Initial Pass/Fail: Fail | Overall Compliance: No |
| Severity Score: 13.75 | | | |

Not Found, R304.2.2, R304.5.3

| Compliance | Description | Data | Compliance | Description | Data |
|---|---|---|---|---|---|
| N/A | Ramp Length (in) | 66.0 | No | Ramp Slope (%) | 9.9 |
| Yes | Ramp Width (in) | 48.0 | No | Ramp XSlope (%) | 2.5 |
| N/A | Gutter Ponding? | Yes | N/A | Gutter Slope (%) | N/A |

Remove & Replace Curb Ramp With Two New Directional Ramps or Equivalent.
