Access Compliance Report

Public Rights-of-Way

(Curb Ramps)

Intersection ID: 51721	Main Street: PROVIDENCE_RD_WEST	Cross Street: BALLANCROFT_PY	Location: NE
ADA ID: 4D11A061EF5F	Ramp Type: Perp	Initial Pass/Fail: Fail	Overall Compliance: No
Severity Score: 12.5			
Codes/Mitigation Info/Possible Solution		Field Measurements/Component Compliance

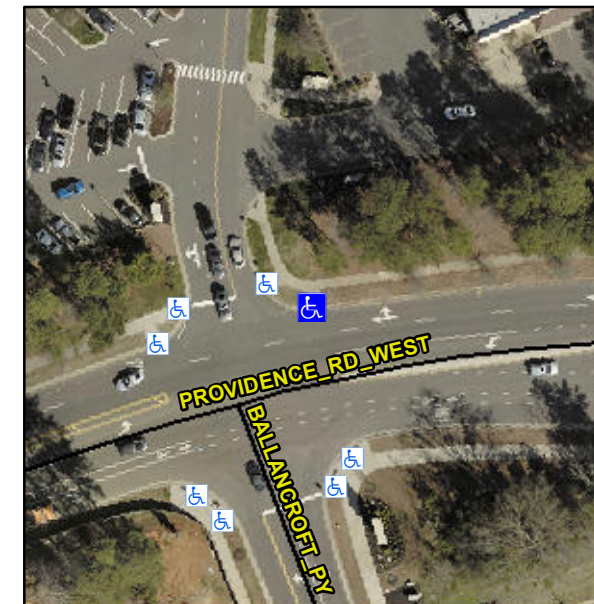
Compliance	Description	Data	Compliance	Description	Data
N/A	Ramp Length (in)	92.0	Yes	Ramp Slope (%)	5.1
Yes	Ramp Width (in)	67.0	No	Ramp XSlope (%)	6.8
N/A	Flare Type LT	N/A	N/A	Flare Type RT	N/A
N/A	Flare Slope LT (%)	N/A	N/A	Flare Slope RT (%)	N/A
N/A	Flare Traversable LT?	N/A	N/A	Flare Traversable RT?	N/A
N/A	Landing Length (in)	N/A	N/A	DWS Provided?	N/A
N/A	Landing Width (in)	N/A	N/A	DWS Contrast?	N/A
N/A	Landing Slope (%)	N/A	N/A	DWS Length (in)	N/A
N/A	Landing X Slope (%)	N/A	N/A	DWS Full Width?	N/A
N/A	Landing Curb? (Y/N)	N/A	N/A	DWS Offset (in)	N/A
N/A	Shared Landing?	N/A			
N/A	Gutter Ponding?	N/A	N/A	Gutter Slope (%)	N/A
N/A	Gutter Lip Ht (in)	N/A	N/A	Gutter X Slope (%)	N/A
N/A	Painted X Walk1?	No	N/A	Painted X Walk2?	N/A
	X Walk 1 Direction	To S		X Walk 2 Direction	N/A
N/A	X Walk 1 Width (in)	N/A	N/A	X Walk 2 Width (in)	N/A
	X Walk 1 Slope (%)	4.3		X Walk 2 Slope (%)	N/A
	X Walk 1 X Slope (%)	3.2		X Walk 2 X Slope (%)	N/A

N/A	Ramp inside XWalk1?	N/A	N/A	Ramp inside XWalk2?	N/A
	Road Slope (%)	N/A	N/A	Clear Space?	N/A
	Road X Slope (%)	N/A	N/A	Clear Space to XWalk (in)	N/A
N/A	Any Obstructions?	N/A	N/A	Storm Grate/Utility Hazard?	N/A
	Obstruction Type			Storm Grate/Utility Type	
		N/A			N/A
		Yes		Surface Condition? (G/P)	Good

Possible Solutions:

Remove & Replace Entire Ramp.

R304.5.3
