# Access Compliance Report

## Public Rights-of-Way

### (Curb Ramps)

Intersection ID: 24072	Main Street: DELOACH_CT	Cross Street: HAWK_CREST_CT	Location: S
ADA ID: 4D19D5109EB2	Ramp Type: PerpDiag	Initial Pass/Fail: Fail	Overall Compliance: No
Severity Score: 21.25			
Codes/Mitigation Info/Possible Solution		Field Measurements/Component Compliance

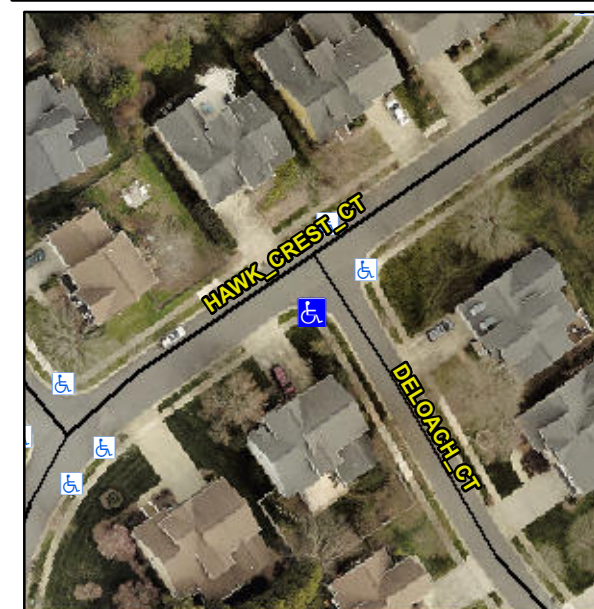
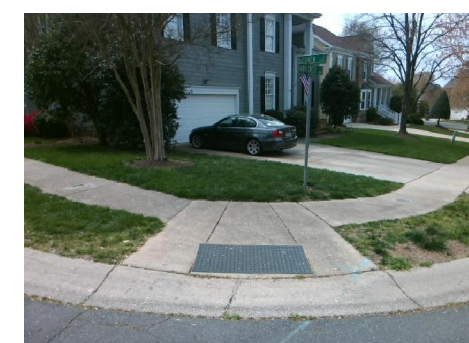
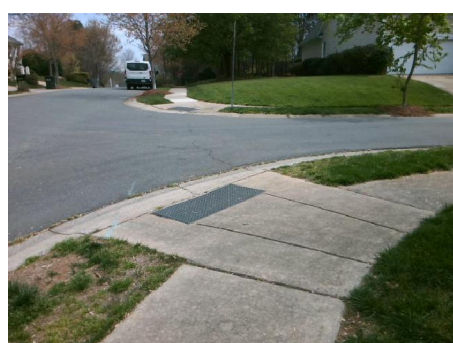
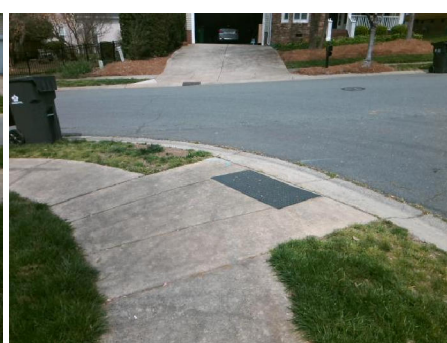
**Not Found, R304.5.1, R304.5.3**

Compliance	Description	Data	Compliance	Description	Data
N/A	Ramp Length (in)	48.0	Yes	Ramp Slope (%)	5.1
No	Ramp Width (in)	37.5	No	Ramp XSlope (%)	5.2
N/A	Flare Type LT	N/A	N/A	Flare Type RT	N/A
N/A	Flare Slope LT (%)	N/A	N/A	Flare Slope RT (%)	N/A
N/A	Flare Traversable LT?	N/A	N/A	Flare Traversable RT?	N/A
N/A	Landing Length (in)	N/A	N/A	DWS Provided?	N/A
N/A	Landing Width (in)	N/A	N/A	DWS Contrast?	N/A
N/A	Landing Slope (%)	N/A	N/A	DWS Length (in)	N/A
N/A	Landing X Slope (%)	N/A	N/A	DWS Full Width?	N/A
N/A	Landing Curb? (Y/N)	N/A	N/A	DWS Offset (in)	N/A
N/A	Shared Landing?	N/A			
N/A	Gutter Ponding?	N/A	N/A	Gutter Slope (%)	N/A
N/A	Gutter Lip Ht (in)	N/A	N/A	Gutter X Slope (%)	N/A
N/A	Painted X Walk1?	No	N/A	Painted X Walk2?	No
	X Walk 1 Direction	To NE		X Walk 2 Direction	To NW
N/A	X Walk 1 Width (in)	N/A	N/A	X Walk 2 Width (in)	N/A
	X Walk 1 Slope (%)	6.4		X Walk 2 Slope (%)	3.9
	X Walk 1 X Slope (%)	0.8		X Walk 2 X Slope (%)	7.7

N/A	Ramp inside XWalk1?	N/A	N/A	Ramp inside XWalk2?	N/A
	Road Slope (%)	4.6	N/A	Clear Space?	N/A
	Road X Slope (%)	7.7	N/A	Clear Space to XWalk (in)	N/A
N/A	Any Obstructions?	N/A	N/A	Storm Grate/Utility Hazard?	N/A
	Obstruction Type			Storm Grate/Utility Type	
		N/A			N/A
			Yes	Surface Condition? (G/P)	Good

**Remove & Replace Curb Ramp With Two New Directional Ramps or Equivalent.**
