Access Compliance Report

Public Rights-of-Way

(Curb Ramps)

Intersection ID: 45775	Main Street: BITTER_CREEK_DR	Cross Street: CARVER_FALLS_RD	Location: E
ADA ID: 4D19D8DEB027	Ramp Type: PerpDiag	Initial Pass/Fail: Fail	Overall Compliance: No
		Severity Score: 12.5

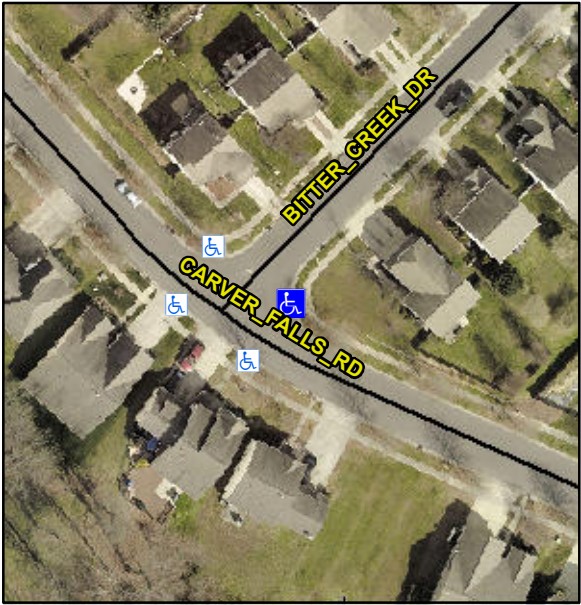
Possible Solutions:		Compliance	Description	Data
	Remove & Replace Curb Ramp With Two New Directional Ramps or Equivalent.		Compliance	Description	Data
<p>Surveyor Notes:</p> <p>N/A</p>			N/A	Ramp Length (in)	60.0
			Yes	Ramp Width (in)	60.0
<p>PROW/ADA:</p> <p>R304.5.3</p>			N/A	Flare Type LT	N/A
			N/A	Flare Slope LT (%)	N/A
			N/A	Flare Traversable LT?	N/A
			N/A	Flare Slope RT (%)	N/A
			N/A	Flare Traversable RT?	N/A
			N/A	DWS Provided?	N/A
			N/A	DWS Contrast?	N/A
			N/A	DWS Length (in)	N/A
			N/A	DWS Full Width?	N/A
			N/A	DWS Offset (in)	N/A
			N/A	Shared Landing?	N/A
			N/A	Gutter Ponding?	N/A
			N/A	Gutter Lip Ht (in)	N/A
			N/A	Painted X Walk1?	No
				X Walk 1 Direction	To NW
			N/A	X Walk 2 Direction	To SW
			N/A	X Walk 1 Width (in)	N/A
			N/A	X Walk 2 Width (in)	N/A
				X Walk 1 Slope (%)	5.4
				X Walk 2 Slope (%)	1.6

X Walk 1 X Slope (%)	2.1
				X Walk 2 X Slope (%)	6.5
			N/A	Ramp inside XWalk1?	N/A
			N/A	Ramp inside XWalk2?	N/A
				Road Slope (%)	5.3
			N/A	Clear Space?	N/A
				Road X Slope (%)	4.6
			N/A	Clear Space to XWalk (in)	N/A
			N/A	Any Obstructions?	N/A
			N/A	Storm Grate/Utility Hazard?	N/A
				Obstruction Type	
			N/A	Storm Grate/Utility Type	
					N/A
			Yes	Surface Condition? (G/P)	Good
