Access Compliance Report

Public Rights-of-Way

(Curb Ramps)

Intersection ID: 16269	Main Street: STERLING_RD	Cross Street: WELLESLEY_AV	Location: NE
ADA ID: 4D1AF8CB7540	Ramp Type: PerpDiag	Initial Pass/Fail: Fail	Overall Compliance: No
		Severity Score: 12.5

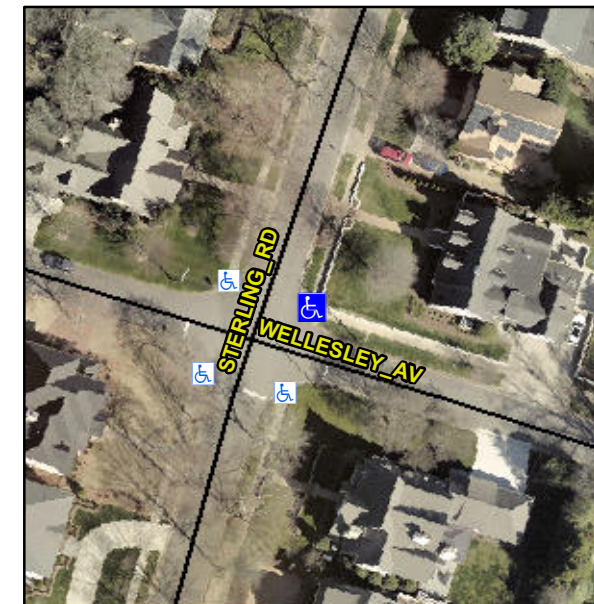
Not Found, R304.2.2

Compliance	Description	Data	Compliance	Description	Data
N/A	Ramp Length (in)	46.0	No	Ramp Slope (%)	9.0
Yes	Ramp Width (in)	55.5	Yes	Ramp XSlope (%)	0.3
N/A	Flare Type LT	N/A	N/A	Flare Type RT	N/A
N/A	Flare Slope LT (%)	N/A	N/A	Flare Slope RT (%)	N/A
N/A	Flare Traversable LT?	N/A	N/A	Flare Traversable RT?	N/A
N/A	Landing Length (in)	N/A	N/A	DWS Provided?	N/A
N/A	Landing Width (in)	N/A	N/A	DWS Contrast?	N/A
N/A	Landing Slope (%)	N/A	N/A	DWS Length (in)	N/A
N/A	Landing X Slope (%)	N/A	N/A	DWS Full Width?	N/A
N/A	Landing Curb? (Y/N)	N/A	N/A	DWS Offset (in)	N/A
N/A	Shared Landing?	N/A			
N/A	Gutter Ponding?	N/A	N/A	Gutter Slope (%)	N/A
N/A	Gutter Lip Ht (in)	1.5	N/A	Gutter X Slope (%)	N/A
N/A	Painted X Walk1?	No	N/A	Painted X Walk2?	No
	X Walk 1 Direction	To NW		X Walk 2 Direction	To SW
N/A	X Walk 1 Width (in)	N/A	N/A	X Walk 2 Width (in)	N/A
	X Walk 1 Slope (%)	2.0		X Walk 2 Slope (%)	0.0
	X Walk 1 X Slope (%)	0.8		X Walk 2 X Slope (%)	0.1

N/A	Ramp inside XWalk1?	N/A	N/A	Ramp inside XWalk2?	N/A
	Road Slope (%)	0.7	N/A	Clear Space?	N/A
	Road X Slope (%)	1.6	N/A	Clear Space to XWalk (in)	N/A
N/A	Any Obstructions?	N/A	N/A	Storm Grate/Utility Hazard?	N/A
	Obstruction Type			Storm Grate/Utility Type	
		N/A			N/A
			Yes	Surface Condition? (G/P)	Good

Remove & Replace Curb Ramp With Two New Directional Ramps or Equivalent.

Total Cost: \$ 3200.00
