Access Compliance Report

Public Rights-of-Way

(Curb Ramps)

Intersection ID: 10031406	Main Street: MCALPINE_PARK_DR	Cross Street: N/A	Location: SW
ADA ID: 4D2BB9BB9504	Ramp Type: PerpDiag	Initial Pass/Fail: Fail	Overall Compliance: No
		Severity Score: 25

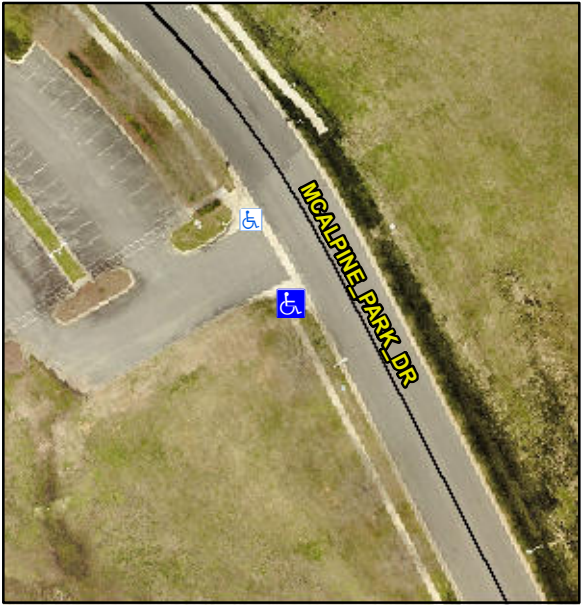
0.9	X Walk 2 Slope (%)	0.8
			2.0	X Walk 2 X Slope (%)	5.4
<p>Surveyor Notes:</p> <p>N/A</p> <p>PROW/ADA:</p> <p>Not Found, R304.5.3</p>			N/A	Ramp inside XWalk1?	N/A

7.8	Ramp inside XWalk2?	N/A
			3.8	Clear Space?	N/A
			N/A	Clear Space to XWalk (in)	N/A
			N/A	Storm Grate/Utility Hazard?	N/A
			N/A	Storm Grate/Utility Type	N/A
			N/A	Surface Condition? (G/P)	Good
Total Cost:		\$ 3200.00

Possible Solutions:		Compliance	Description	Data
	Remove & Replace Curb Ramp With Two New Directional Ramps or Equivalent.		Yes	Ramp Length (in)	67.0
			N/A	Ramp Width (in)	48.0
			N/A	Flare Type LT	N/A
			N/A	Flare Slope LT (%)	N/A
			N/A	Flare Traversable LT?	N/A
			N/A	Flare Type RT	N/A
			N/A	Flare Slope RT (%)	N/A
			N/A	Flare Traversable RT?	N/A
			N/A	DWS Provided?	N/A
			N/A	DWS Contrast?	N/A
			N/A	DWS Length (in)	N/A
			N/A	DWS Full Width?	N/A
			N/A	DWS Offset (in)	N/A
			N/A	Gutter Ponding?	N/A
			N/A	Gutter X Slope (%)	N/A
			No	Painted X Walk1?	No
			To E	X Walk 2 Direction	To N
			N/A	X Walk 2 Width (in)	N/A
