Access Compliance Report

Public Rights-of-Way

(Curb Ramps)

Intersection ID: 10024552	Main Street: D_DUCKS_LN	Cross Street: N/A	Location: NE
ADA ID: 4D2D86DD7B83	Ramp Type: PerpDiag	Initial Pass/Fail: Fail	Overall Compliance: No
		Severity Score: 22.5

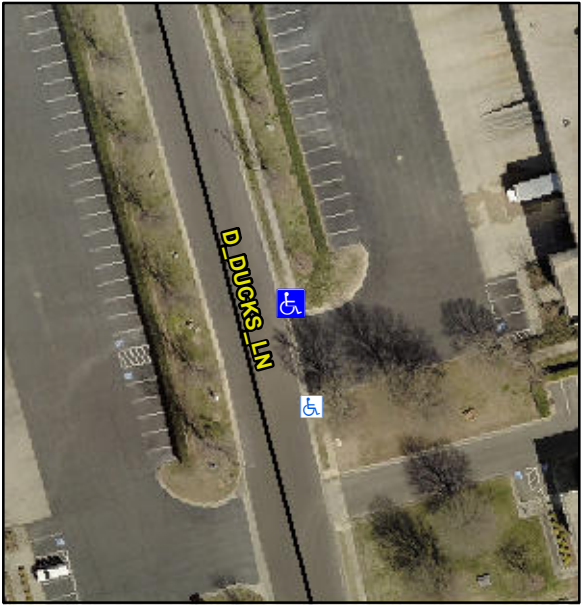
Possible Solutions:		Compliance	Description	Data
	Remove & Replace Curb Ramp With Two New Directional Ramps or Equivalent.		No	Ramp Length (in)	46.0
			No	Ramp Width (in)	42.0
			N/A	Flare Type LT	N/A
			N/A	Flare Slope LT (%)	N/A
			N/A	Flare Traversable LT?	N/A
			N/A	Landing Length (in)	N/A
			N/A	Landing Width (in)	N/A
			N/A	Landing Slope (%)	N/A
			N/A	Landing X Slope (%)	N/A
			N/A	Landing Curb? (Y/N)	N/A
			N/A	Shared Landing?	N/A
			N/A	Gutter Ponding?	N/A
			N/A	Gutter Lip Ht (in)	N/A
			No	Painted X Walk1?	No
				X Walk 1 Direction	To W
			N/A	X Walk 1 Width (in)	N/A
				X Walk 1 Slope (%)	1.2
				X Walk 1 X Slope (%)	0.3
			N/A	Ramp inside XWalk1?	N/A
<p>Surveyor Notes:</p> <p>N/A</p> <p>PROW/ADA:</p> <p>R304.5.1, R304.2.2, R304.5.3</p>			N/A	Flare Type RT	N/A
			N/A	Flare Slope RT (%)	N/A
			N/A	Flare Traversable RT?	N/A

N/A	DWS Provided?	N/A
			N/A	DWS Contrast?	N/A
			N/A	DWS Length (in)	N/A
			N/A	DWS Full Width?	N/A
			N/A	DWS Offset (in)	N/A
			N/A	Gutter Slope (%)	N/A
			N/A	Gutter X Slope (%)	N/A
			No	Painted X Walk2?	No
				X Walk 2 Direction	To S
			N/A	X Walk 2 Width (in)	N/A
				X Walk 2 Slope (%)	0.4
				X Walk 2 X Slope (%)	2.6
			N/A	Ramp inside XWalk2?	N/A
			N/A	Clear Space?	N/A
			N/A	Clear Space to XWalk (in)	N/A
			N/A	Storm Grate/Utility Hazard?	N/A
				Storm Grate/Utility Type	
			N/A		N/A
			Yes	Surface Condition? (G/P)	Good
Street 1 Name	D DUCKS LN				
Stop Condition-Street 2	None				
Street 2 Name	ENTRANCE				
Stop Condition-Street 1	StopSign				
Total Cost:	\$ 3200.00
