# Access Compliance Report

## Public Rights-of-Way

### (Curb Ramps)

Intersection ID: 48437	Main Street: LATHERTON_LN	Cross Street: CULLEN_CT	Location: NE
ADA ID: 4D3158AB6200	Ramp Type: PerpDiag	Initial Pass/Fail: Fail	Overall Compliance: No
Severity Score: 8.75			
Codes/Mitigation Info/Possible Solution		Field Measurements/Component Compliance

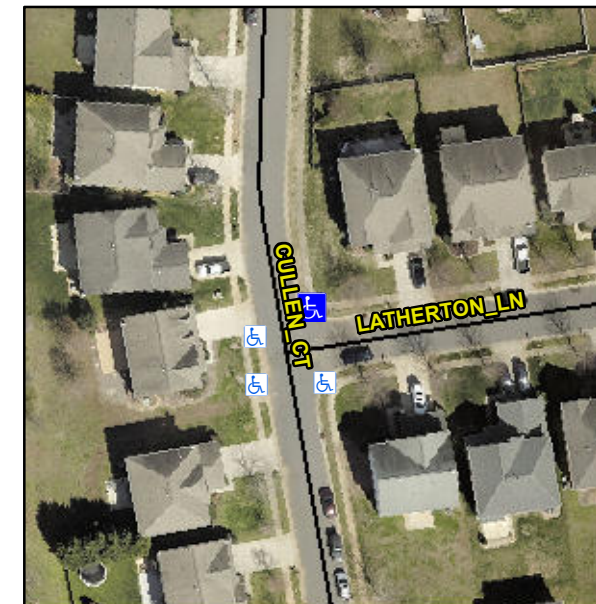
Compliance	Description	Data	Compliance	Description	Data
N/A	Ramp Length (in)	46.0	Yes	Ramp Slope (%)	5.4
No	Ramp Width (in)	45.0	Yes	Ramp XSlope (%)	1.2
N/A	Flare Type LT	N/A	N/A	Flare Type RT	N/A
N/A	Flare Slope LT (%)	N/A	N/A	Flare Slope RT (%)	N/A
N/A	Flare Traversable LT?	N/A	N/A	Flare Traversable RT?	N/A
N/A	Landing Length (in)	N/A	N/A	DWS Provided?	N/A
N/A	Landing Width (in)	N/A	N/A	DWS Contrast?	N/A
N/A	Landing Slope (%)	N/A	N/A	DWS Length (in)	N/A
N/A	Landing X Slope (%)	N/A	N/A	DWS Full Width?	N/A
N/A	Landing Curb? (Y/N)	N/A	N/A	DWS Offset (in)	N/A
N/A	Shared Landing?	N/A			
N/A	Gutter Ponding?	N/A	N/A	Gutter Slope (%)	N/A
N/A	Gutter Lip Ht (in)	N/A	N/A	Gutter X Slope (%)	N/A
N/A	Painted X Walk1?	No	N/A	Painted X Walk2?	No
	X Walk 1 Direction	To W		X Walk 2 Direction	To S
N/A	X Walk 1 Width (in)	N/A	N/A	X Walk 2 Width (in)	N/A
	X Walk 1 Slope (%)	1.7		X Walk 2 Slope (%)	2.5
	X Walk 1 X Slope (%)	0.6		X Walk 2 X Slope (%)	1.9

N/A	Ramp inside XWalk1?	N/A	N/A	Ramp inside XWalk2?	N/A
	Road Slope (%)	1.4	N/A	Clear Space?	N/A
	Road X Slope (%)	1.7	N/A	Clear Space to XWalk (in)	N/A
N/A	Any Obstructions?	N/A	N/A	Storm Grate/Utility Hazard?	N/A
	Obstruction Type			Storm Grate/Utility Type	
		N/A			N/A
		Yes		Surface Condition? (G/P)	Good

Possible Solutions:

**Remove & Replace Curb Ramp With Two New Directional Ramps or Equivalent.**

PROW/ADA:

**R304.5.1**
