Access Compliance Report

Public Rights-of-Way

(Curb Ramps)

Intersection ID: 10224	Main Street: HERRIN_AV	Cross Street: SPENCER_ST	Location: SW
ADA ID: 4D3387547E40	Ramp Type: Combination1	Initial Pass/Fail: Fail	Overall Compliance: No
Severity Score: 33.75			
Codes/Mitigation Info/Possible Solution		Field Measurements/Component Compliance

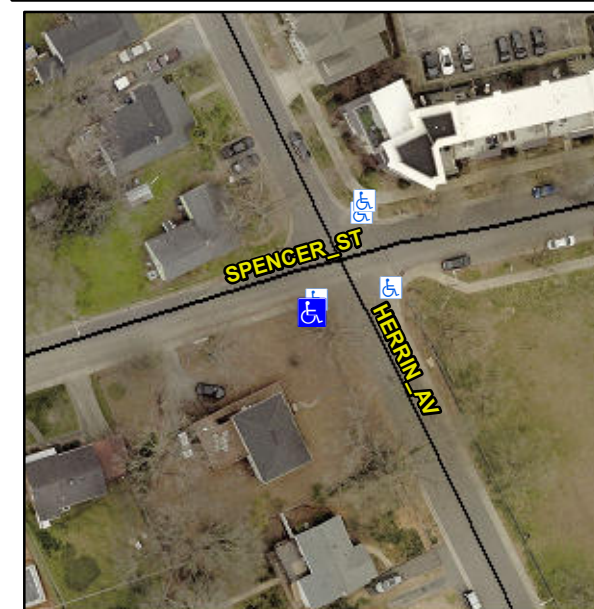
RT RP < 5%

Not Found, R304.5.1, R304.5.3, R304.3.2

Possible Solutions:

Remove & Replace Entire Ramp.

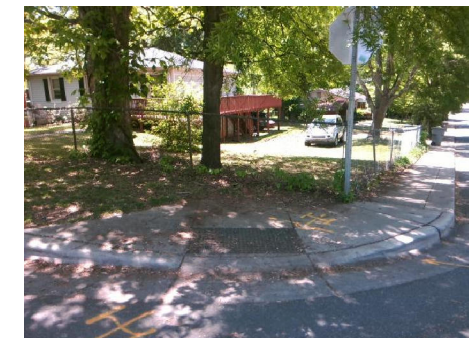
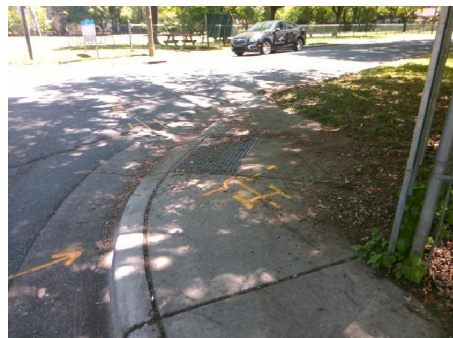
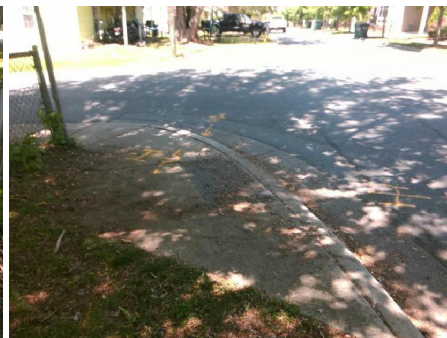
Compliance	Description	Data	Compliance	Description	Data
N/A	Ramp Length LT (in)	66.5	N/A	Ramp Length RT (in)	64.0
Yes	Ramp Width LT (in)	67.5	Yes	Ramp Width RT (in)	67.5
No	Ramp Slope LT (%)	9.9	Yes	Ramp Slope RT (%)	3.2
Yes	Ramp XSlope LT (%)	0.9	Yes	Ramp XSlope RT (%)	0.4
N/A	Ramp Length (in)	67.5	Yes	Ramp Slope (%)	4.7
No	Ramp Width (in)	47.0	No	Ramp XSlope (%)	5.1
N/A	Flare Type LT	N/A	N/A	Flare Type RT	N/A
N/A	Flare Slope LT (%)	N/A	N/A	Flare Slope RT (%)	N/A
N/A	Flare Traversable LT?	N/A	N/A	Flare Traversable RT?	N/A
N/A	Landing Length (in)	N/A	N/A	DWS Provided?	N/A
N/A	Landing Width (in)	N/A	N/A	DWS Contrast?	N/A
N/A	Landing Slope (%)	N/A	N/A	DWS Length (in)	N/A
N/A	Landing X Slope (%)	N/A	N/A	DWS Full Width?	N/A
N/A	Landing Curb? (Y/N)	N/A	N/A	DWS Offset (in)	N/A
N/A	Shared Landing?	N/A			
N/A	Gutter Ponding?	N/A	N/A	Gutter Slope (%)	N/A
N/A	Gutter Lip Ht (in)	N/A	N/A	Gutter X Slope (%)	N/A
N/A	Painted X Walk1?	No	N/A	Painted X Walk2?	N/A

X Walk 1 Direction	To E		X Walk 2 Direction	N/A
	X Walk 1 Width (in)	N/A		X Walk 2 Width (in)	N/A
	X Walk 1 Slope (%)	4.9		X Walk 2 Slope (%)	N/A
	X Walk 1 X Slope (%)	1.8		X Walk 2 X Slope (%)	N/A
N/A	Ramp inside XWalk1?	N/A	N/A	Ramp inside XWalk2?	N/A
	Road Slope (%)	N/A		Clear Space?	N/A
	Road X Slope (%)	N/A	N/A	Clear Space to XWalk (in)	N/A
			N/A	Any Obstruction?	N/A
				Obstruction Type	N/A
			N/A	Storm Grate/Utility Hazard?	N/A
				Storm Grate/Utility Type	N/A
			Yes	Surface Condition? (G/P)	Good
				Curb Slope (%)	15.1
