# Access Compliance Report

## Public Rights-of-Way

### (Curb Ramps)

| Intersection ID: 54269 | Main Street: JOHNSTON_OEHLER_RD | Cross Street: OEHLER_BRIDGE_DR | Location: E |

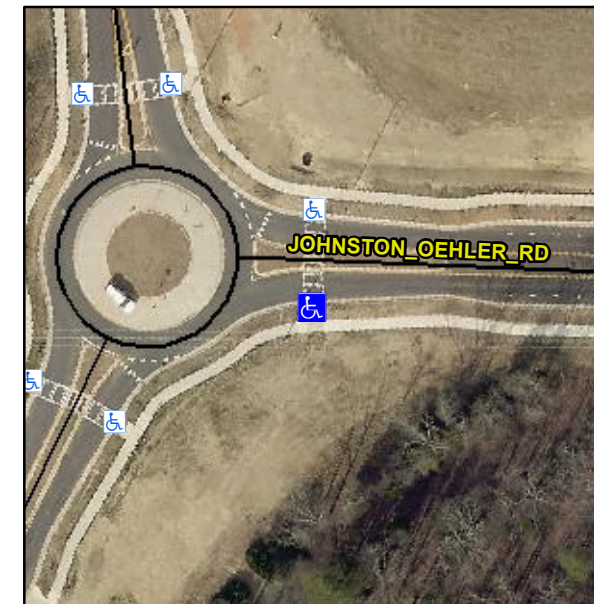
| Compliance | Description | Data | Compliance | Description | Data |
|---|---|---|---|---|---|
| No | Landing Slope (%) | 2.2 | Yes | DWS Length (in) | 24.0 |
| No | Gutter Ponding? | Yes | Yes | Gutter Slope (%) | 0.5 |

**Remove & Replace Landing. Gutter Ponding Observed.**
