Access Compliance Report

Public Rights-of-Way

(Curb Ramps)

Intersection ID: 53339	Main Street: NORTHLAKE CENTRE PY	Cross Street: CALHOUN ST	Location: NW
ADA ID: 4D47FE313A56	Ramp Type: Perp	Initial Pass/Fail: Fail	Overall Compliance: No
Codes/Mitigation Info/Possible Solution		Field Measurements/Component Compliance	
Severity Score: 8.75

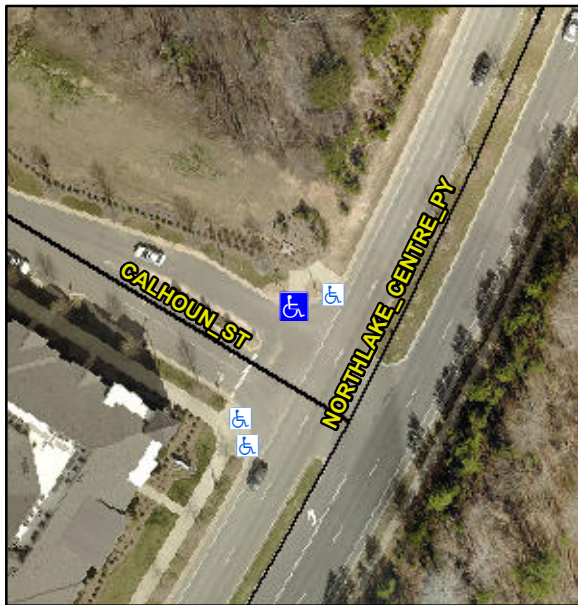
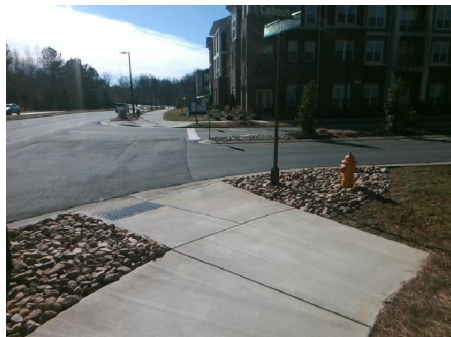
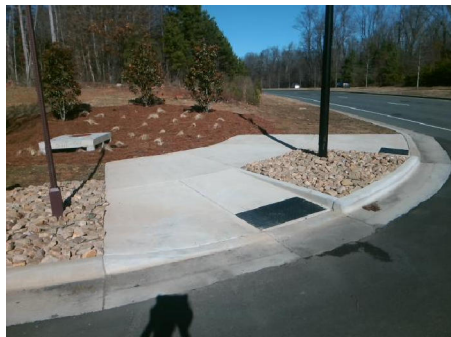
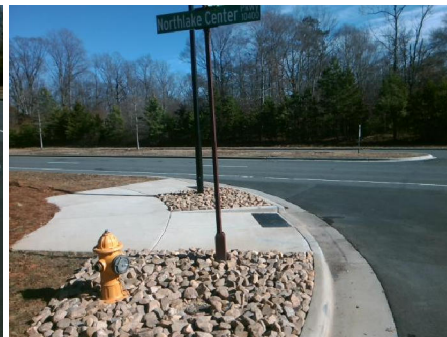
Compliance	Description	Data	Compliance	Description	Data
N/A	Ramp Length (in)	98.0	Yes	Ramp Slope (%)	6.5
No	Ramp Width (in)	46.0	Yes	Ramp XSlope (%)	1.1
N/A	Flare Type LT	N/A	N/A	Flare Type RT	N/A
N/A	Flare Slope LT (%)	N/A	N/A	Flare Slope RT (%)	N/A
N/A	Flare Traversable LT?	N/A	N/A	Flare Traversable RT?	N/A
N/A	Landing Length (in)	N/A	N/A	DWS Provided?	N/A
N/A	Landing Width (in)	N/A	N/A	DWS Contrast?	N/A
N/A	Landing Slope (%)	N/A	N/A	DWS Length (in)	N/A
N/A	Landing X Slope (%)	N/A	N/A	DWS Full Width?	N/A
N/A	Landing Curb? (Y/N)	N/A	N/A	DWS Offset (in)	N/A
N/A	Shared Landing?	N/A			
N/A	Gutter Ponding?	N/A	N/A	Gutter Slope (%)	N/A
N/A	Gutter Lip Ht (in)	N/A	N/A	Gutter X Slope (%)	N/A
N/A	Painted X Walk1?	No	N/A	Painted X Walk2?	N/A
	X Walk 1 Direction	To SW		X Walk 2 Direction	N/A
N/A	X Walk 1 Width (in)	N/A	N/A	X Walk 2 Width (in)	N/A
	X Walk 1 Slope (%)	0.5		X Walk 2 Slope (%)	N/A
	X Walk 1 X Slope (%)	0.1		X Walk 2 X Slope (%)	N/A

N/A	Ramp inside XWalk1?	N/A	N/A	Ramp inside XWalk2?	N/A
	Road Slope (%)	N/A	N/A	Clear Space?	N/A
	Road X Slope (%)	N/A	N/A	Clear Space to XWalk (in)	N/A
N/A	Any Obstructions?	N/A	N/A	Storm Grate/Utility Hazard?	N/A
	Obstruction Type			Storm Grate/Utility Type	
		N/A			N/A
			Yes	Surface Condition? (G/P)	Good

Remove & Replace Entire Ramp.

R304.5.1
