Access Compliance Report

Public Rights-of-Way

(Curb Ramps)

Intersection ID: 26811	Main Street: LINKSIDE_CT	Cross Street: OLD_COURSE_DR	Location: NE
ADA ID: 4D4CD3B587FB	Ramp Type: BlendTrans1	Initial Pass/Fail: Fail	Overall Compliance: No
Severity Score: 8.75			
Codes/Mitigation Info/Possible Solution		Field Measurements/Component Compliance

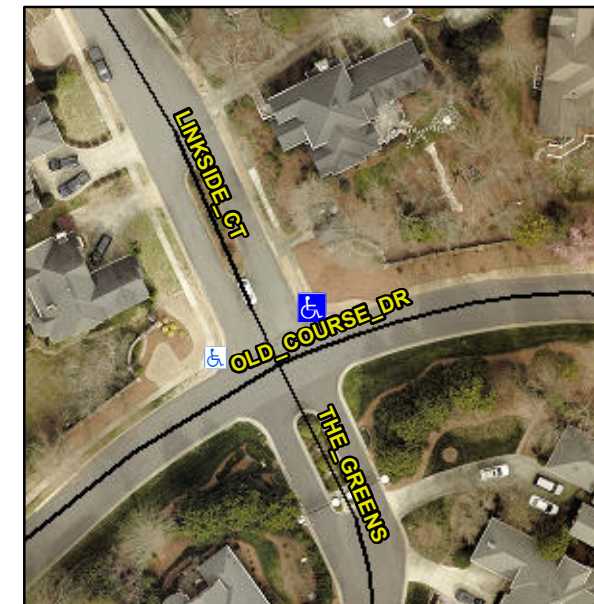
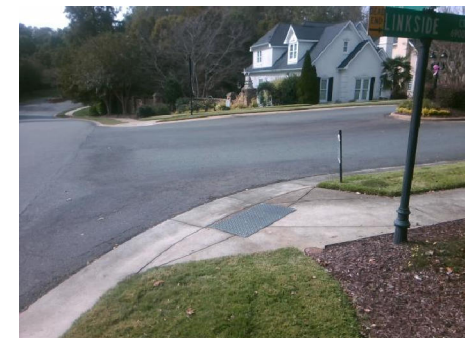
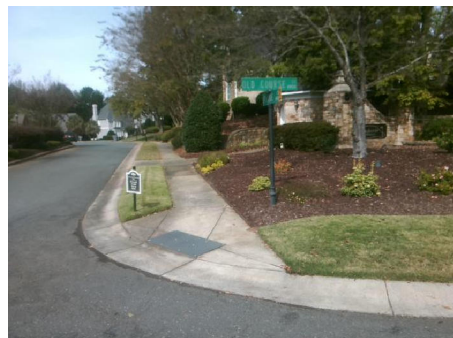
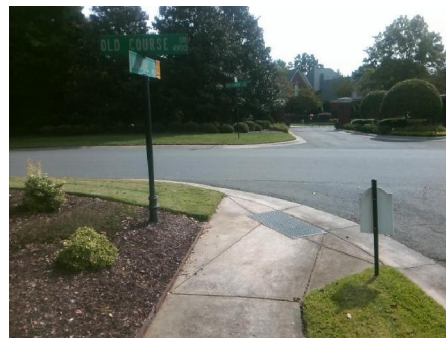
Not Found, R304.5.1

Compliance	Description	Data	Compliance	Description	Data
N/A	Ramp Length (in)	84.0	Yes	BlendTrans Slope (%)	3.5
No	Ramp Width (in)	41.0	Yes	BlendTrans XSlope (%)	0.8
N/A	Flare Type LT	N/A	N/A	Flare Type RT	N/A
N/A	Flare Slope LT (%)	N/A	N/A	Flare Slope RT (%)	N/A
N/A	Flare Traversable LT?	N/A	N/A	Flare Traversable RT?	N/A
N/A	Landing Length (in)	N/A	N/A	DWS Provided?	N/A
N/A	Landing Width (in)	N/A	N/A	DWS Contrast?	N/A
N/A	Landing Slope (%)	N/A	N/A	DWS Length (in)	N/A
N/A	Landing X Slope (%)	N/A	N/A	DWS Full Width?	N/A
N/A	Landing Curb? (Y/N)	N/A	N/A	DWS Offset (in)	N/A
N/A	Shared Landing?	N/A			
N/A	Gutter Ponding?	N/A	N/A	Gutter Slope (%)	N/A
N/A	Gutter Lip Ht (in)	N/A	N/A	Gutter X Slope (%)	N/A
N/A	Painted X Walk1?	No	N/A	Painted X Walk2?	No
	X Walk 1 Direction	To SW		X Walk 2 Direction	To SE
	X Walk 1 Width (in)	N/A		X Walk 2 Width (in)	N/A
	X Walk 1 Slope (%)	0.5		X Walk 2 Slope (%)	0.9
	X Walk 1 X Slope (%)	1.4		X Walk 2 X Slope (%)	1.8

N/A	Ramp inside XWalk1?	N/A	N/A	Ramp inside XWalk2?	N/A
	Road Slope (%)	1.3		Clear Space?	N/A
	Road X Slope (%)	2.9	N/A	Clear Space to XWalk (in)	N/A
N/A	Any Obstructions?	N/A	N/A	Storm Grate/Utility Hazard?	N/A
	Obstruction Type			Storm Grate/Utility Type	
		N/A			N/A
			Yes	Surface Condition? (G/P)	Good
			No	Curb Slope (%)	7.2

Remove & Replace Curb Ramp With Two New Directional Ramps or Equivalent.

Total Cost: \$ 3200.00
