# Access Compliance Report

## Public Rights-of-Way

### (Curb Ramps)

Intersection ID: 10016181	Main Street: CENTRAL_AV	Cross Street: N/A	Location: N
ADA ID: 4D599D624212	Ramp Type: Para	Initial Pass/Fail: Fail	Overall Compliance: No
		Severity Score: 12.5

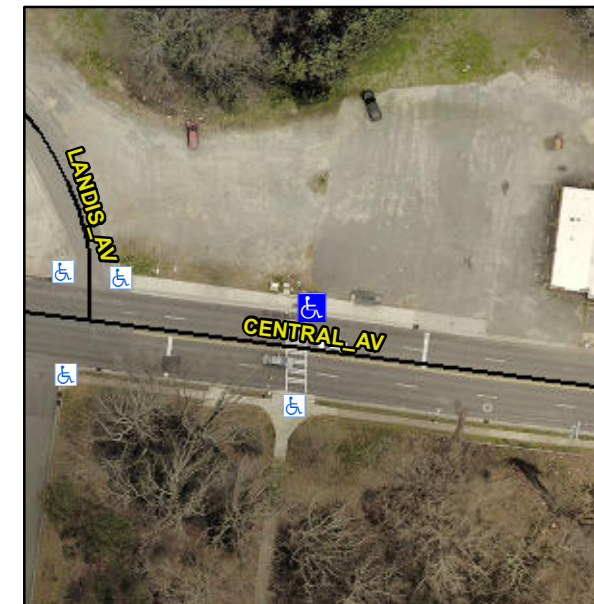
Compliance	Description	Data	Compliance	Description	Data
N/A	Ramp Length LT (in)	98.5	N/A	Ramp Length RT (in)	96.0
Yes	Ramp Width LT (in)	70.0	Yes	Ramp Width RT (in)	70.0
No	Ramp Slope LT (%)	9.8	Yes	Ramp Slope RT (%)	5.4
Yes	Ramp XSlope LT (%)	0.9	Yes	Ramp XSlope RT (%)	1.7
N/A	Landing Length (in)	N/A	N/A	DWS Provided?	N/A
N/A	Landing Width (in)	N/A	N/A	DWS Contrast?	N/A
N/A	Landing Slope (%)	N/A	N/A	DWS Length (in)	N/A
N/A	Landing X Slope (%)	N/A	N/A	DWS Full Width?	N/A
N/A	Landing Curb? (Y/N)	N/A	N/A	DWS Offset (in)	N/A
N/A	Shared Landing?	N/A			
N/A	Gutter Ponding?	N/A	N/A	Gutter Slope (%)	N/A
N/A	Gutter Lip Ht (in)	N/A	N/A	Gutter X Slope (%)	N/A
N/A	Painted X Walk1?	Yes	N/A	Painted X Walk2?	N/A
	X Walk 1 Direction	To S		X Walk 2 Direction	N/A
N/A	X Walk 1 Width (in)	115.0	N/A	X Walk 2 Width (in)	N/A
	X Walk 1 Slope (%)	7.1		X Walk 2 Slope (%)	N/A
	X Walk 1 X Slope (%)	3.1		X Walk 2 X Slope (%)	N/A
N/A	Ramp inside XWalk1?	Yes	N/A	Ramp inside XWalk2?	N/A

Road Slope (%)	N/A	N/A	Clear Space?	N/A
	Road X Slope (%)	N/A	N/A	Clear Space to XWalk (in)	N/A
N/A	Any Obstructions?	N/A	N/A	Storm Grate/Utility Hazard?	N/A
	Obstruction Type			Storm Grate/Utility Type	
		N/A			N/A
			Yes	Surface Condition? (G/P)	Good
			N/A	Curb Slope (%)	9.1

Possible Solutions:

**Remove & Replace Entire Ramp.**

**R304.3.2**
