Access Compliance Report

Public Rights-of-Way

(Curb Ramps)

Intersection ID: 42943	Main Street: LONG_PAW_LN	Cross Street: SONOMA_VALLEY_DR	Location:	N
ADA ID: 4D5D686F81AA	Ramp Type: PerpDiag	Initial Pass/Fail: Fail	Overall Compliance: No	Severity Score: 8.75
Codes/Mitigation Info/Possible Solution		Field Measurements/Component Compliance

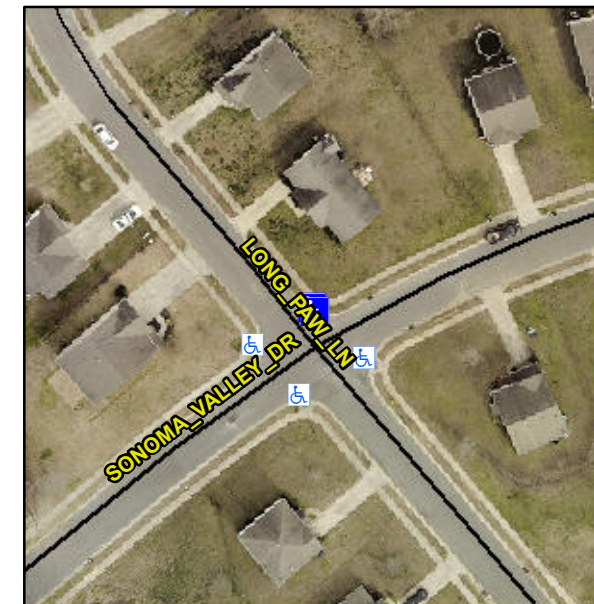
Not Found, R304.5.1

Compliance	Description	Data	Compliance	Description	Data
N/A	Ramp Length (in)	49.5	Yes	Ramp Slope (%)	5.0
No	Ramp Width (in)	46.5	Yes	Ramp XSlope (%)	1.3
N/A	Flare Type LT	N/A	N/A	Flare Type RT	N/A
N/A	Flare Slope LT (%)	N/A	N/A	Flare Slope RT (%)	N/A
N/A	Flare Traversable LT?	N/A	N/A	Flare Traversable RT?	N/A
N/A	Landing Length (in)	N/A	N/A	DWS Provided?	N/A
N/A	Landing Width (in)	N/A	N/A	DWS Contrast?	N/A
N/A	Landing Slope (%)	N/A	N/A	DWS Length (in)	N/A
N/A	Landing X Slope (%)	N/A	N/A	DWS Full Width?	N/A
N/A	Landing Curb? (Y/N)	N/A	N/A	DWS Offset (in)	N/A
N/A	Shared Landing?	N/A			
N/A	Gutter Ponding?	N/A	N/A	Gutter Slope (%)	N/A
N/A	Gutter Lip Ht (in)	N/A	N/A	Gutter X Slope (%)	N/A
N/A	Painted X Walk1?	No	N/A	Painted X Walk2?	No
	X Walk 1 Direction	To SW		X Walk 2 Direction	To SE
N/A	X Walk 1 Width (in)	N/A	N/A	X Walk 2 Width (in)	N/A
	X Walk 1 Slope (%)	3.1		X Walk 2 Slope (%)	6.6
	X Walk 1 X Slope (%)	3.1		X Walk 2 X Slope (%)	2.1

N/A	Ramp inside XWalk1?	N/A	N/A	Ramp inside XWalk2?	N/A
	Road Slope (%)	0.5	N/A	Clear Space?	N/A
	Road X Slope (%)	5.2	N/A	Clear Space to XWalk (in)	N/A
N/A	Any Obstructions?	N/A	N/A	Storm Grate/Utility Hazard?	N/A
	Obstruction Type			Storm Grate/Utility Type	
		N/A			N/A
			Yes	Surface Condition? (G/P)	Good

Remove & Replace Curb Ramp With Two New Directional Ramps or Equivalent.
