# Access Compliance Report

## Public Rights-of-Way

### (Curb Ramps)

Intersection ID: 2834	Main Street: GLEN_MANOR_DR	Cross Street: NOBILITY_CT	Location: NW
ADA ID: 4D6441AF7434	Ramp Type: PerpDiag	Initial Pass/Fail: Fail	Overall Compliance: No
		Severity Score: 10

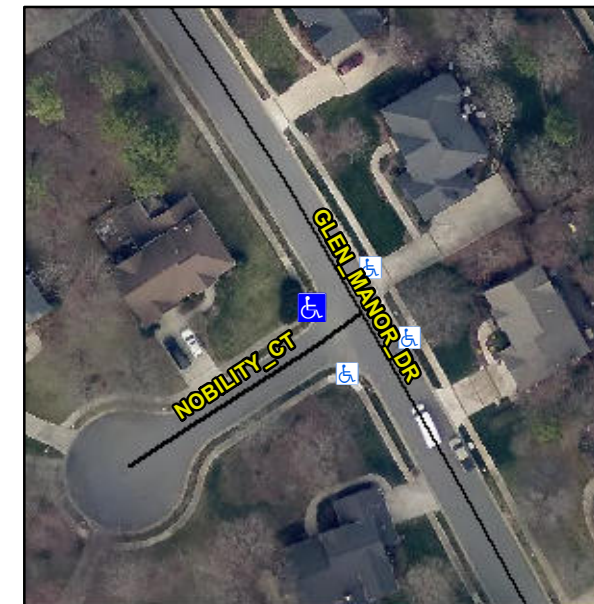
**Not Found, R304.5.1, R304.5.3**

Compliance	Description	Data	Compliance	Description	Data
N/A	Ramp Length (in)	33.0	Yes	Ramp Slope (%)	5.7
No	Ramp Width (in)	43.0	No	Ramp XSlope (%)	4.1
N/A	Flare Type LT	N/A	N/A	Flare Type RT	N/A
N/A	Flare Slope LT (%)	N/A	N/A	Flare Slope RT (%)	N/A
N/A	Flare Traversable LT?	N/A	N/A	Flare Traversable RT?	N/A
N/A	Landing Length (in)	N/A	N/A	DWS Provided?	N/A
N/A	Landing Width (in)	N/A	N/A	DWS Contrast?	N/A
N/A	Landing Slope (%)	N/A	N/A	DWS Length (in)	N/A
N/A	Landing X Slope (%)	N/A	N/A	DWS Full Width?	N/A
N/A	Landing Curb? (Y/N)	N/A	N/A	DWS Offset (in)	N/A
N/A	Shared Landing?	N/A			
N/A	Gutter Ponding?	N/A	N/A	Gutter Slope (%)	N/A
N/A	Gutter Lip Ht (in)	N/A	N/A	Gutter X Slope (%)	N/A
N/A	Painted X Walk1?	No	N/A	Painted X Walk2?	No
	X Walk 1 Direction	To S		X Walk 2 Direction	To E
N/A	X Walk 1 Width (in)	N/A	N/A	X Walk 2 Width (in)	N/A
	X Walk 1 Slope (%)	0.6		X Walk 2 Slope (%)	3.4
	X Walk 1 X Slope (%)	1.1		X Walk 2 X Slope (%)	3.0

N/A	Ramp inside XWalk1?	N/A	N/A	Ramp inside XWalk2?	N/A
	Road Slope (%)	1.4	N/A	Clear Space?	N/A
	Road X Slope (%)	1.1	N/A	Clear Space to XWalk (in)	N/A
N/A	Any Obstructions?	N/A	N/A	Storm Grate/Utility Hazard?	N/A
	Obstruction Type			Storm Grate/Utility Type	
		N/A			N/A
			Yes	Surface Condition? (G/P)	Good

**Remove & Replace Curb Ramp With Two New Directional Ramps or Equivalent.**
