# Access Compliance Report

## Public Rights-of-Way

### (Curb Ramps)

| Intersection ID: 15317 | Main Street: FOSTER_AV | Cross Street: NEW_BERN_ST | Location: S |

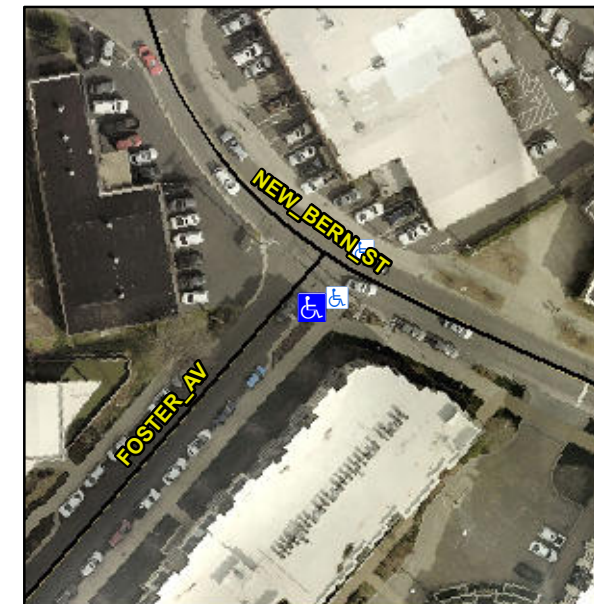
**Not Found, R304.2.2-Perp, R304.3.2-Para, R304.5.3**

| Compliance | Description | Data | Compliance | Description | Data |
|---|---|---|---|---|---|
| No | Landing Slope (%) | 2.8 | Yes | DWS Length (in) | 24.0 |
| Yes | Gutter Lip Ht (in) | 0.0 | No | Gutter X Slope (%) | 2.6 |

**Remove & Replace Entire Ramp.  
Remove & Replace Gutter.**
