Access Compliance Report

Public Rights-of-Way

(Curb Ramps)

Intersection ID: 28009	Main Street: BAY_HILL_CLUB_DR	Cross Street: OAKLAND_HILLS_PL	Location: SW
ADA ID: 4D72DC4E7DA7	Ramp Type: Perp	Initial Pass/Fail: Fail	Overall Compliance: No
Severity Score: 12.5			
Codes/Mitigation Info/Possible Solution		Field Measurements/Component Compliance

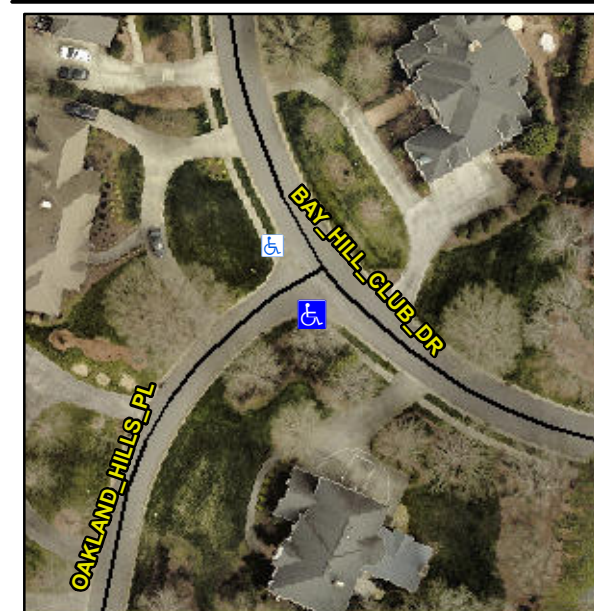
Not Found, R304.2.2

Compliance	Description	Data	Compliance	Description	Data
N/A	Ramp Length (in)	25.0	No	Ramp Slope (%)	10.0
Yes	Ramp Width (in)	96.0	Yes	Ramp XSlope (%)	0.6
N/A	Flare Type LT	N/A	N/A	Flare Type RT	N/A
N/A	Flare Slope LT (%)	N/A	N/A	Flare Slope RT (%)	N/A
N/A	Flare Traversable LT?	N/A	N/A	Flare Traversable RT?	N/A
N/A	Landing Length (in)	N/A	N/A	DWS Provided?	N/A
N/A	Landing Width (in)	N/A	N/A	DWS Contrast?	N/A
N/A	Landing Slope (%)	N/A	N/A	DWS Length (in)	N/A
N/A	Landing X Slope (%)	N/A	N/A	DWS Full Width?	N/A
N/A	Landing Curb? (Y/N)	N/A	N/A	DWS Offset (in)	N/A
N/A	Shared Landing?	N/A			
N/A	Gutter Ponding?	N/A	N/A	Gutter Slope (%)	N/A
N/A	Gutter Lip Ht (in)	N/A	N/A	Gutter X Slope (%)	N/A
N/A	Painted X Walk1?	No	N/A	Painted X Walk2?	N/A
	X Walk 1 Direction	To NW		X Walk 2 Direction	N/A
N/A	X Walk 1 Width (in)	N/A	N/A	X Walk 2 Width (in)	N/A
	X Walk 1 Slope (%)	3.0		X Walk 2 Slope (%)	N/A
	X Walk 1 X Slope (%)	0.1		X Walk 2 X Slope (%)	N/A

Possible Solutions:

Remove & Replace Entire Ramp.

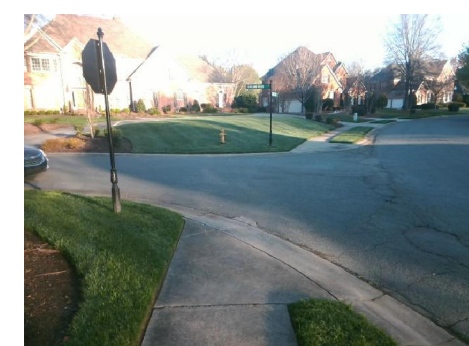
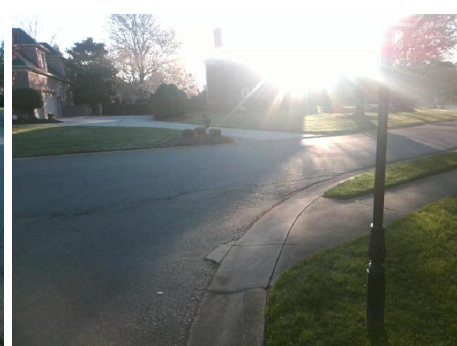
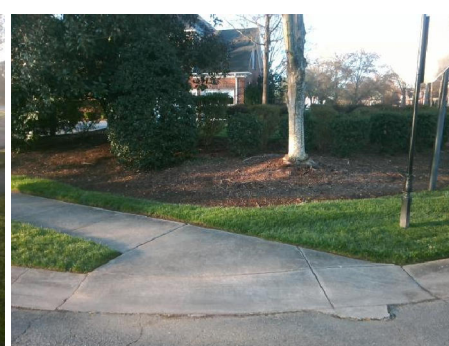
N/A	Ramp inside XWalk1?	N/A	N/A	Ramp inside XWalk2?	N/A
	Road Slope (%)	N/A	N/A	Clear Space?	N/A
	Road X Slope (%)	N/A	N/A	Clear Space to XWalk (in)	N/A
N/A	Any Obstructions?	N/A	N/A	Storm Grate/Utility Hazard?	N/A
	Obstruction Type			Storm Grate/Utility Type	
		N/A			N/A
			Yes	Surface Condition? (G/P)	Good
