Access Compliance Report

Public Rights-of-Way

(Curb Ramps)

Intersection ID: 17169	Main Street: IDLEWILD_RD	Cross Street: CEDARS_EAST_CT	Location: SE
ADA ID: 4D731A535DBB	Ramp Type: Perp	Initial Pass/Fail: Fail	Overall Compliance: No
		Severity Score: 12.5

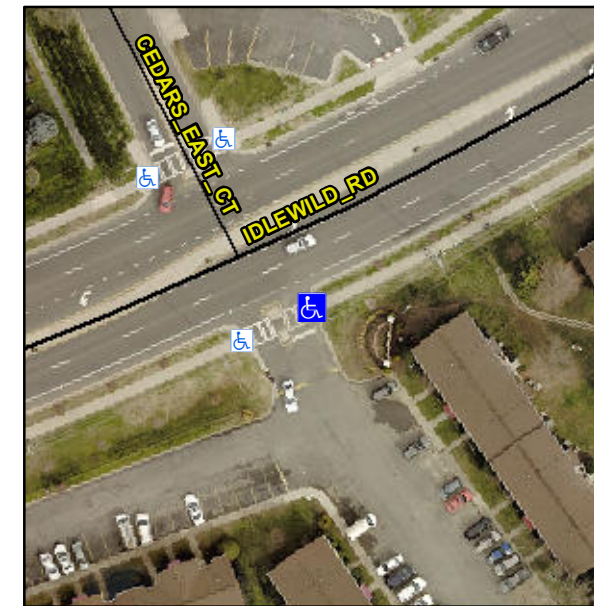
Not Found, R304.2.2

Compliance	Description	Data	Compliance	Description	Data
N/A	Ramp Length (in)	77.0	No	Ramp Slope (%)	8.5
Yes	Ramp Width (in)	48.0	Yes	Ramp XSlope (%)	1.2
N/A	Flare Type LT	N/A	N/A	Flare Type RT	N/A
N/A	Flare Slope LT (%)	N/A	N/A	Flare Slope RT (%)	N/A
N/A	Flare Traversable LT?	N/A	N/A	Flare Traversable RT?	N/A
N/A	Landing Length (in)	N/A	N/A	DWS Provided?	N/A
N/A	Landing Width (in)	N/A	N/A	DWS Contrast?	N/A
N/A	Landing Slope (%)	N/A	N/A	DWS Length (in)	N/A
N/A	Landing X Slope (%)	N/A	N/A	DWS Full Width?	N/A
N/A	Landing Curb? (Y/N)	N/A	N/A	DWS Offset (in)	N/A
N/A	Shared Landing?	N/A			
N/A	Gutter Ponding?	N/A	N/A	Gutter Slope (%)	N/A
N/A	Gutter Lip Ht (in)	N/A	N/A	Gutter X Slope (%)	N/A
N/A	Painted X Walk1?	Yes	N/A	Painted X Walk2?	N/A
	X Walk 1 Direction	To W		X Walk 2 Direction	N/A
N/A	X Walk 1 Width (in)	111.0	N/A	X Walk 2 Width (in)	N/A
	X Walk 1 Slope (%)	0.0		X Walk 2 Slope (%)	N/A
	X Walk 1 X Slope (%)	0.8		X Walk 2 X Slope (%)	N/A

N/A	Ramp inside XWalk1?	Yes	N/A	Ramp inside XWalk2?	N/A
	Road Slope (%)	N/A	N/A	Clear Space?	N/A
	Road X Slope (%)	N/A	N/A	Clear Space to XWalk (in)	N/A
N/A	Any Obstructions?	N/A	N/A	Storm Grate/Utility Hazard?	N/A
	Obstruction Type			Storm Grate/Utility Type	
		N/A			N/A
		Yes		Surface Condition? (G/P)	Good

Remove & Replace Entire Ramp.
