Access Compliance Report Public Rights-of-Way (Curb Ramps)

Intersection ID: 10006Main Street:CALTON_LNCross Street:DANIEL_LNLocation:NEADA ID: 4D81969A60CDRamp Type:PerpDiagInitial Pass/Fail:FailOverall Compliance:NoSeverity Score:60

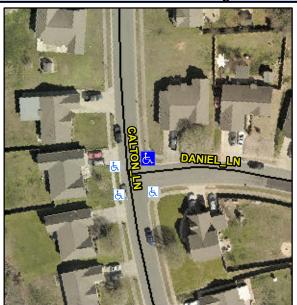
Field Measurements/Component Compliance						
Compliance Description		Data	Comp	liance Description	Data	
N/A	Ramp Length (in)	48.0	Yes	Ramp Slope (%)	5.7	
No	Ramp Width (in)	27.0	No	Ramp XSlope (%)	8.3	
N/A	Flare Type LT	N/A	N/A	Flare Type RT	N/A	
N/A	Flare Slope LT (%)	N/A	N/A	Flare Slope RT (%)	N/A	
N/A	Flare Traversable LT?	N/A	N/A	Flare Traversable RT?	N/A	
N/A	Landing Length (in)	N/A	N/A	DWS Provided?	N/A	
N/A	Landing Width (in)	N/A	N/A	DWS Contrast?	N/A	
N/A	Landing Slope (%)	N/A	N/A	DWS Length (in)	N/A	
N/A	Landing X Slope (%)	N/A	N/A	DWS Full Width?	N/A	
N/A	Landing Curb? (Y/N)	N/A	N/A	DWS Offset (in)	N/A	
N/A	Shared Landing?	N/A				
N/A	Gutter Ponding?	N/A	N/A	Gutter Slope (%)	N/A	
N/A	Gutter Lip Ht (in)	N/A	N/A	Gutter X Slope (%)	N/A	
N/A	Painted X Walk1?	No	N/A	Painted X Walk2?	No	
	X Walk 1 Direction	To W		X Walk 2 Direction	To S	
N/A	X Walk 1 Width (in)	N/A	N/A	X Walk 2 Width (in)	N/A	
	X Walk 1 Slope (%)	6.3		X Walk 2 Slope (%)	1.4

X Walk 1 X Slope (%)	3.9		X Walk 2 X Slope (%)	6.2	
N/A	Ramp inside XWalk1?	N/A	N/A	Ramp inside XWalk2?	N/A	
	Road Slope (%)	6.7	N/A	Clear Space?	N/A	
	Road X Slope (%)	2.6	N/A	Clear Space to XWalk (in)	N/A	
N/A	Any Obstructions?	N/A	N/A	Storm Grate/Utility Hazard?	N/A	
	Obstruction Type			Storm Grate/Utility Type		
		N/A			N/A	
			Yes	Surface Condition? (G/P)	Good

i ossible ociulion
Possible Solutions:
Remove & Replace Curb Ramp With Two New Directional Ramps or Equivalent.
Surveyor Notes: N/A
PROW/ADA: Not Found, R304.5.1, R304.5.3

3200.00
