# Access Compliance Report

## Public Rights-of-Way

### (Curb Ramps)

Intersection ID: 5337	Main Street: UNIVERSITY_CITY_BV	Cross Street: OAK_LEIGH_DR	Location:	N
ADA ID: 4D85132713C6	Ramp Type: Perp	Initial Pass/Fail: Fail	Overall Compliance: No	Severity Score: 35
Codes/Mitigation Info/Possible Solution		Field Measurements/Component Compliance

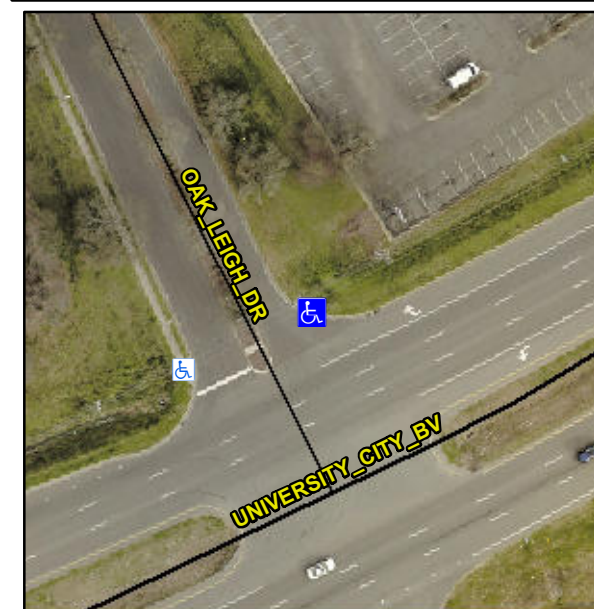
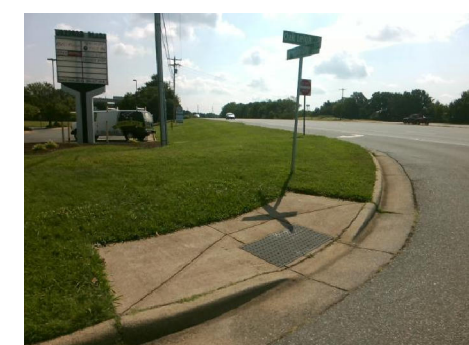
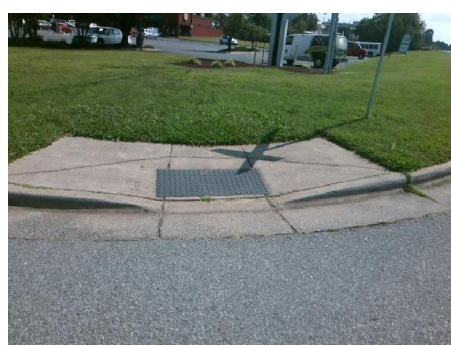
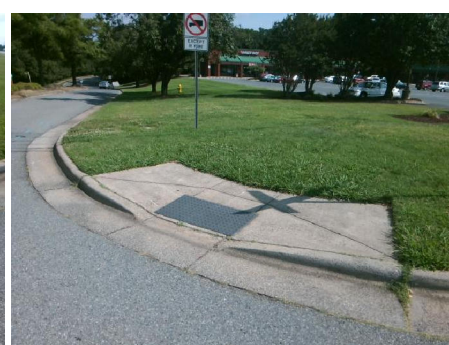
Compliance	Description	Data	Compliance	Description	Data
N/A	Ramp Length (in)	39.0	No	Ramp Slope (%)	17.5
No	Ramp Width (in)	40.0	No	Ramp XSlope (%)	2.1
N/A	Flare Type LT	N/A	N/A	Flare Type RT	N/A
N/A	Flare Slope LT (%)	N/A	N/A	Flare Slope RT (%)	N/A
N/A	Flare Traversable LT?	N/A	N/A	Flare Traversable RT?	N/A
N/A	Landing Length (in)	N/A	N/A	DWS Provided?	N/A
N/A	Landing Width (in)	N/A	N/A	DWS Contrast?	N/A
N/A	Landing Slope (%)	N/A	N/A	DWS Length (in)	N/A
N/A	Landing X Slope (%)	N/A	N/A	DWS Full Width?	N/A
N/A	Landing Curb? (Y/N)	N/A	N/A	DWS Offset (in)	N/A
N/A	Shared Landing?	N/A			
N/A	Gutter Ponding?	N/A	N/A	Gutter Slope (%)	N/A
N/A	Gutter Lip Ht (in)	N/A	N/A	Gutter X Slope (%)	N/A
N/A	Painted X Walk1?	No	N/A	Painted X Walk2?	N/A
	X Walk 1 Direction	To W		X Walk 2 Direction	N/A
N/A	X Walk 1 Width (in)	N/A	N/A	X Walk 2 Width (in)	N/A
	X Walk 1 Slope (%)	3.3		X Walk 2 Slope (%)	N/A
	X Walk 1 X Slope (%)	4.5		X Walk 2 X Slope (%)	N/A

N/A	Ramp inside XWalk1?	N/A	N/A	Ramp inside XWalk2?	N/A
	Road Slope (%)	N/A	N/A	Clear Space?	N/A
	Road X Slope (%)	N/A	N/A	Clear Space to XWalk (in)	N/A
N/A	Any Obstructions?	N/A	N/A	Storm Grate/Utility Hazard?	N/A
	Obstruction Type			Storm Grate/Utility Type	
		N/A			N/A
			Yes	Surface Condition? (G/P)	Good

**Remove & Replace Entire Ramp.**

**R304.5.1, R304.2.2, R304.5.3**
