Access Compliance Report Public Rights-of-Way (Curb Ramps)

Intersection ID: 53210 Main Street: HARPER_CT Cross Street: PARK_SOUTH_DR Location: NW ADA ID: 4D88783CC2AE Ramp Type: PerpDiag Initial Pass/Fail: Fail **Overall Compliance: No** Severity Score: 13.75

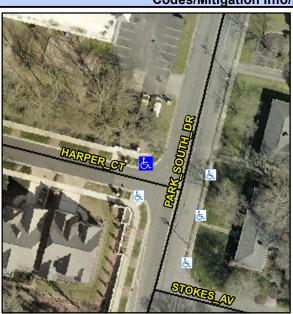
HARPER CT Street 1 Name Stop Condition-Street 2 StopSign Street 2 Name PARK SOUTH DR Stop Condition-Street 1

| N/A | Ramp Length (in) | 96.0 | No | Ramp Slope (%) | 8.8 |
| Yes | Ramp Width (in) | 48.0 | No | Ramp XSlope (%) | 3.0 |

Remove & Replace Curb Ramp With Two New Directional Ramps or Equivalent. Surveyor Notes:

R304.2.2, R304.5.3
