Access Compliance Report

Public Rights-of-Way

(Curb Ramps)

Intersection ID: 22484	Main Street: RIVER_OAKS_LN	Cross Street: SHARON_VIEW_RD	Location: NE
ADA ID: 4D9C8B187CAF	Ramp Type: PerpDiag	Initial Pass/Fail: Fail	Overall Compliance: No
		Severity Score: 8.75

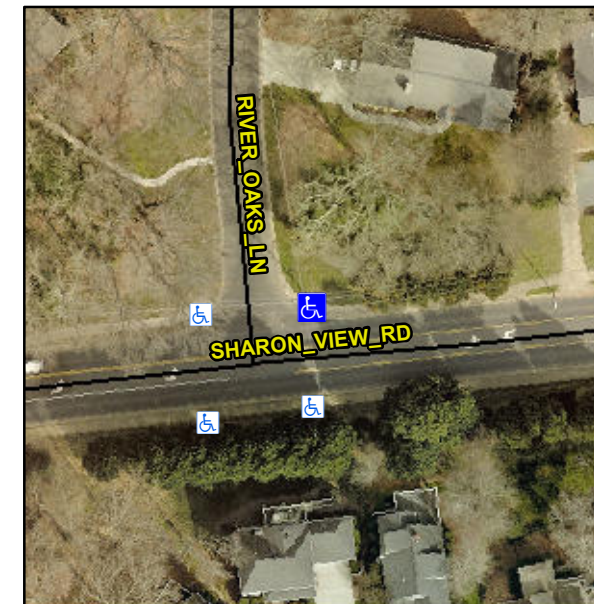
Compliance	Description	Data	Compliance	Description	Data
N/A	Ramp Length (in)	57.0	Yes	Ramp Slope (%)	6.5
No	Ramp Width (in)	42.0	Yes	Ramp XSlope (%)	1.3
N/A	Flare Type LT	N/A	N/A	Flare Type RT	N/A
N/A	Flare Slope LT (%)	N/A	N/A	Flare Slope RT (%)	N/A
N/A	Flare Traversable LT?	N/A	N/A	Flare Traversable RT?	N/A
N/A	Landing Length (in)	N/A	N/A	DWS Provided?	N/A
N/A	Landing Width (in)	N/A	N/A	DWS Contrast?	N/A
N/A	Landing Slope (%)	N/A	N/A	DWS Length (in)	N/A
N/A	Landing X Slope (%)	N/A	N/A	DWS Full Width?	N/A
N/A	Landing Curb? (Y/N)	N/A	N/A	DWS Offset (in)	N/A
N/A	Shared Landing?	N/A			
N/A	Gutter Ponding?	N/A	N/A	Gutter Slope (%)	N/A
N/A	Gutter Lip Ht (in)	N/A	N/A	Gutter X Slope (%)	N/A
N/A	Painted X Walk1?	No	N/A	Painted X Walk2?	No
	X Walk 1 Direction	To W		X Walk 2 Direction	To S
N/A	X Walk 1 Width (in)	N/A	N/A	X Walk 2 Width (in)	N/A
	X Walk 1 Slope (%)	0.2		X Walk 2 Slope (%)	0.1
	X Walk 1 X Slope (%)	0.2		X Walk 2 X Slope (%)	0.4

N/A	Ramp inside XWalk1?	N/A	N/A	Ramp inside XWalk2?	N/A
	Road Slope (%)	0.2	N/A	Clear Space?	N/A
	Road X Slope (%)	1.0	N/A	Clear Space to XWalk (in)	N/A
N/A	Any Obstructions?	N/A	N/A	Storm Grate/Utility Hazard?	N/A
	Obstruction Type			Storm Grate/Utility Type	
		N/A			N/A
		Yes		Surface Condition? (G/P)	Good

Remove & Replace Curb Ramp With Two New Directional Ramps or Equivalent.
