Intersection ID: 16387	Main Street: BILLINGSLEY_RD	Cross Street: CONSERVANCY_LN	Location:	SE
ADA ID: 4DA546848216	Ramp Type: PerpDiag	Initial Pass/Fail: Fail	Overall Compliance: No	Severity Score: 21.25

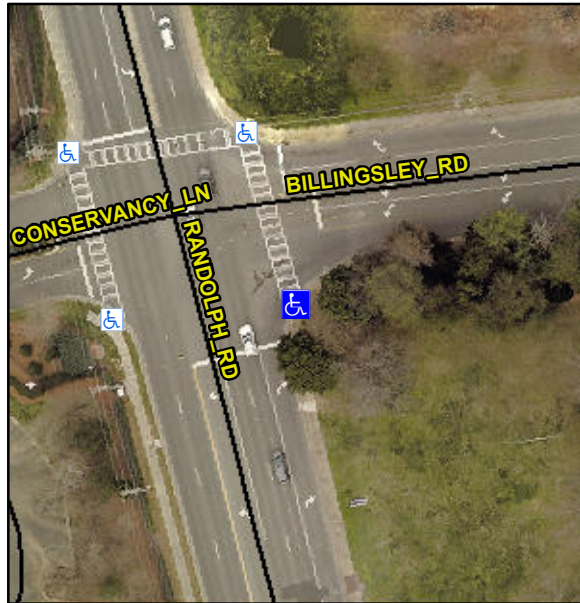
Not Found, R304.5.1, R304.2.2

Compliance	Description	Data	Compliance	Description	Data
N/A	Ramp Length (in)	74.0	No	Ramp Slope (%)	11.5
No	Ramp Width (in)	42.0	Yes	Ramp XSlope (%)	0.5
N/A	Flare Type LT	N/A	N/A	Flare Type RT	N/A
N/A	Flare Slope LT (%)	N/A	N/A	Flare Slope RT (%)	N/A
N/A	Flare Traversable LT?	N/A	N/A	Flare Traversable RT?	N/A
N/A	Landing Length (in)	N/A	N/A	DWS Provided?	N/A
N/A	Landing Width (in)	N/A	N/A	DWS Contrast?	N/A
N/A	Landing Slope (%)	N/A	N/A	DWS Length (in)	N/A
N/A	Landing X Slope (%)	N/A	N/A	DWS Full Width?	N/A
N/A	Landing Curb? (Y/N)	N/A	N/A	DWS Offset (in)	N/A
N/A	Shared Landing?	N/A			
N/A	Gutter Ponding?	N/A	N/A	Gutter Slope (%)	N/A
N/A	Gutter Lip Ht (in)	N/A	N/A	Gutter X Slope (%)	N/A
N/A	Painted X Walk1?	Yes	N/A	Painted X Walk2?	No
	X Walk 1 Direction	To N		X Walk 2 Direction	To W
N/A	X Walk 1 Width (in)	110.0	N/A	X Walk 2 Width (in)	N/A
	X Walk 1 Slope (%)	0.4		X Walk 2 Slope (%)	1.1
	X Walk 1 X Slope (%)	2.9		X Walk 2 X Slope (%)	4.6

N/A	Ramp inside XWalk1?	Yes	N/A	Ramp inside XWalk2?	N/A
	Road Slope (%)	1.3	N/A	Clear Space?	N/A
	Road X Slope (%)	3.4	N/A	Clear Space to XWalk (in)	N/A
N/A	Any Obstructions?	N/A	N/A	Storm Grate/Utility Hazard?	N/A
	Obstruction Type			Storm Grate/Utility Type	
		N/A			N/A
			Yes	Surface Condition? (G/P)	Good

Remove & Replace Curb Ramp With Two New Directional Ramps or Equivalent.
