# Access Compliance Report

## Public Rights-of-Way

### (Curb Ramps)

Intersection ID: 45497	Main Street: ELIZABETH_CREST_LN	Cross Street: COTTON_PRESS_RD	Location: SW
ADA ID: 4DA65D5CA0B6	Ramp Type: Perp	Initial Pass/Fail: Fail	Overall Compliance: No
Severity Score: 12.5			
Codes/Mitigation Info/Possible Solution		Field Measurements/Component Compliance

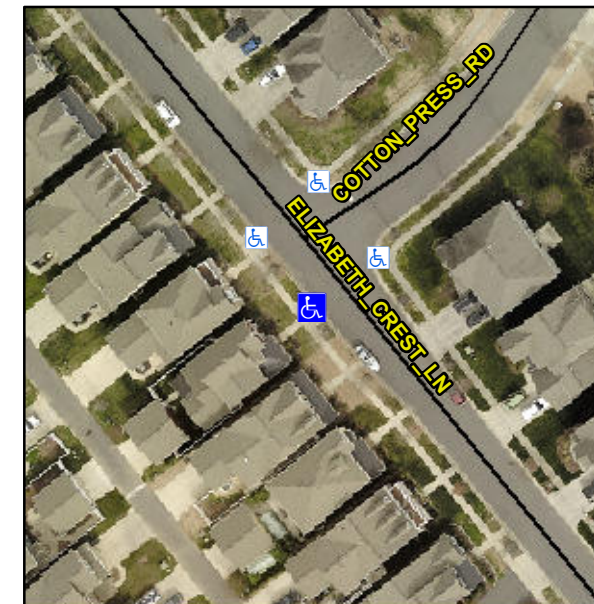
**Not Found, R304.2.2**

Compliance	Description	Data	Compliance	Description	Data
N/A	Ramp Length (in)	71.0	No	Ramp Slope (%)	9.0
Yes	Ramp Width (in)	48.0	Yes	Ramp XSlope (%)	1.6
N/A	Flare Type LT	N/A	N/A	Flare Type RT	N/A
N/A	Flare Slope LT (%)	N/A	N/A	Flare Slope RT (%)	N/A
N/A	Flare Traversable LT?	N/A	N/A	Flare Traversable RT?	N/A
N/A	Landing Length (in)	N/A	N/A	DWS Provided?	N/A
N/A	Landing Width (in)	N/A	N/A	DWS Contrast?	N/A
N/A	Landing Slope (%)	N/A	N/A	DWS Length (in)	N/A
N/A	Landing X Slope (%)	N/A	N/A	DWS Full Width?	N/A
N/A	Landing Curb? (Y/N)	N/A	N/A	DWS Offset (in)	N/A
N/A	Shared Landing?	N/A			
N/A	Gutter Ponding?	N/A	N/A	Gutter Slope (%)	N/A
N/A	Gutter Lip Ht (in)	N/A	N/A	Gutter X Slope (%)	N/A
N/A	Painted X Walk1?	No	N/A	Painted X Walk2?	N/A
	X Walk 1 Direction	To NE		X Walk 2 Direction	N/A
N/A	X Walk 1 Width (in)	N/A	N/A	X Walk 2 Width (in)	N/A
	X Walk 1 Slope (%)	3.0		X Walk 2 Slope (%)	N/A
	X Walk 1 X Slope (%)	10.0		X Walk 2 X Slope (%)	N/A

N/A	Ramp inside XWalk1?	N/A	N/A	Ramp inside XWalk2?	N/A
	Road Slope (%)	N/A	N/A	Clear Space?	N/A
	Road X Slope (%)	N/A	N/A	Clear Space to XWalk (in)	N/A
N/A	Any Obstructions?	N/A	N/A	Storm Grate/Utility Hazard?	N/A
	Obstruction Type			Storm Grate/Utility Type	
		N/A			N/A
			Yes	Surface Condition? (G/P)	Good

Possible Solutions:

**Remove & Replace Entire Ramp.**

Total Cost: \$ 1850.00
