Access Compliance Report

Public Rights-of-Way

(Curb Ramps)

Intersection ID: N/A	Main Street: AMBROSIA_ST	Cross Street: N/A	Location: S
ADA ID: 4DCE8EE6FB02	Ramp Type: Perp	Initial Pass/Fail: Fail	Overall Compliance: No
Severity Score: 26.25			
Codes/Mitigation Info/Possible Solution		Field Measurements/Component Compliance

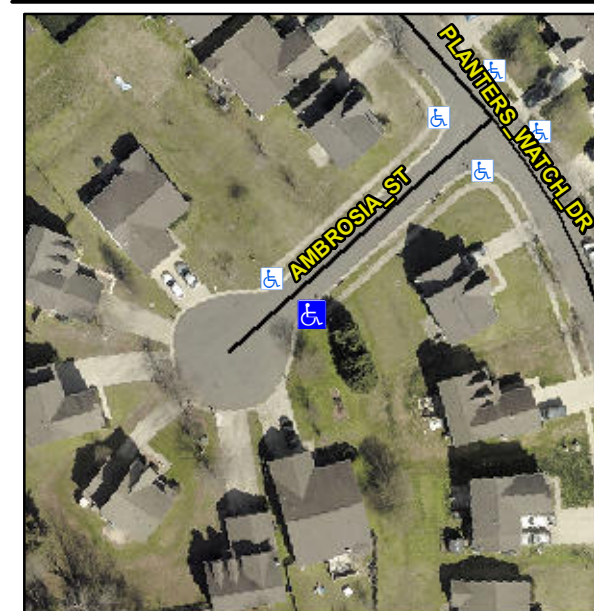
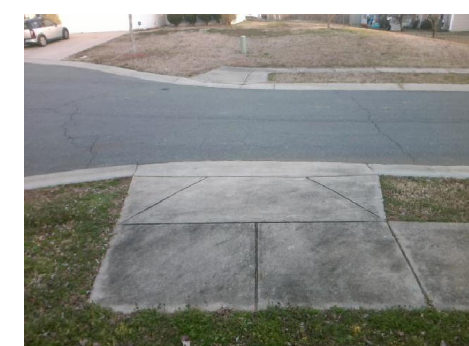
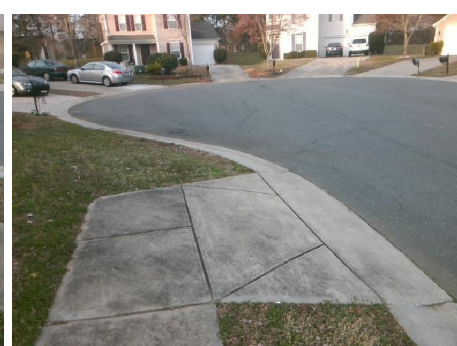
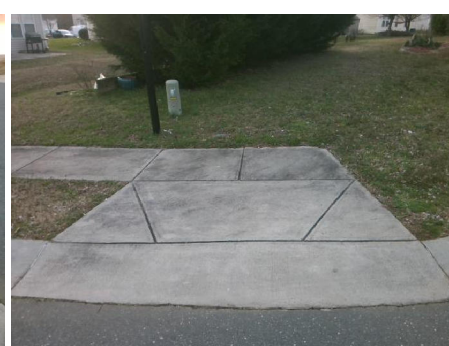
Not Found, R304.2.2

Compliance	Description	Data	Compliance	Description	Data
N/A	Ramp Length (in)	48.0	No	Ramp Slope (%)	12.9
Yes	Ramp Width (in)	51.0	Yes	Ramp XSlope (%)	4.7
N/A	Flare Type LT	N/A	N/A	Flare Type RT	N/A
N/A	Flare Slope LT (%)	N/A	N/A	Flare Slope RT (%)	N/A
N/A	Flare Traversable LT?	N/A	N/A	Flare Traversable RT?	N/A
N/A	Landing Length (in)	N/A	N/A	DWS Provided?	N/A
N/A	Landing Width (in)	N/A	N/A	DWS Contrast?	N/A
N/A	Landing Slope (%)	N/A	N/A	DWS Length (in)	N/A
N/A	Landing X Slope (%)	N/A	N/A	DWS Full Width?	N/A
N/A	Landing Curb? (Y/N)	N/A	N/A	DWS Offset (in)	N/A
N/A	Shared Landing?	N/A			
N/A	Gutter Ponding?	N/A	N/A	Gutter Slope (%)	N/A
N/A	Gutter Lip Ht (in)	N/A	N/A	Gutter X Slope (%)	N/A
N/A	Painted X Walk1?	No	N/A	Painted X Walk2?	N/A
	X Walk 1 Direction	To NW		X Walk 2 Direction	N/A
N/A	X Walk 1 Width (in)	N/A	N/A	X Walk 2 Width (in)	N/A
	X Walk 1 Slope (%)	1.1		X Walk 2 Slope (%)	N/A
	X Walk 1 X Slope (%)	5.1		X Walk 2 X Slope (%)	N/A

N/A	Ramp inside XWalk1?	N/A	N/A	Ramp inside XWalk2?	N/A
	Road Slope (%)	N/A	N/A	Clear Space?	N/A
	Road X Slope (%)	N/A	N/A	Clear Space to XWalk (in)	N/A
N/A	Any Obstructions?	N/A	N/A	Storm Grate/Utility Hazard?	N/A
	Obstruction Type			Storm Grate/Utility Type	
		N/A			N/A
		Yes		Surface Condition? (G/P)	Good

Possible Solutions:

Remove & Replace Entire Ramp.
