Access Compliance Report

Public Rights-of-Way

(Curb Ramps)

Intersection ID: 48411	Main Street: NEVIN_RD	Cross Street: BELMAR_PLACE_RD	Location: N
ADA ID: 4DE49AE17538	Ramp Type: Perp	Initial Pass/Fail: Fail	Overall Compliance: No
Severity Score: 13.75			
Codes/Mitigation Info/Possible Solution		Field Measurements/Component Compliance

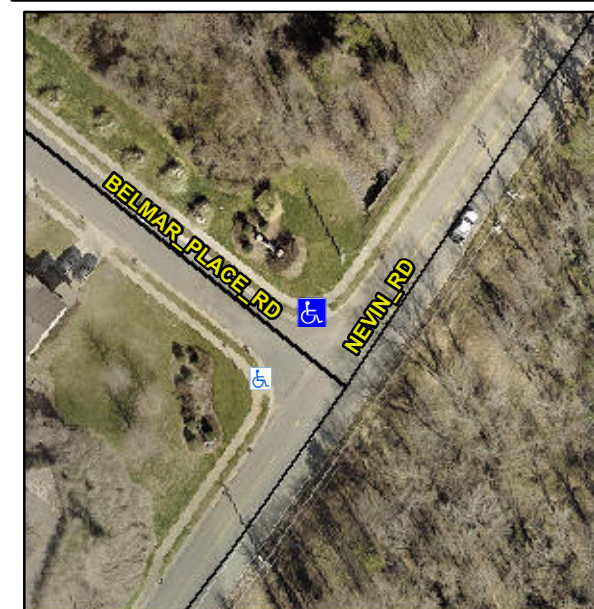
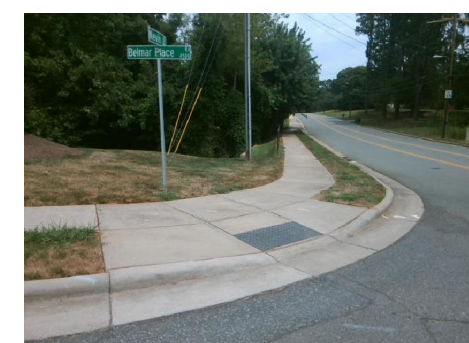
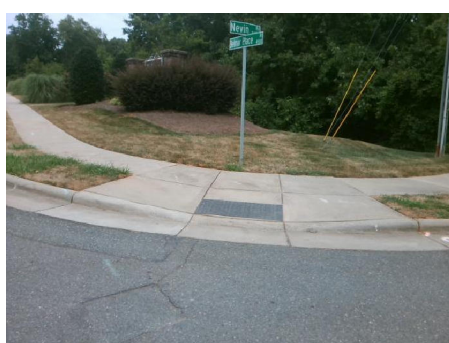
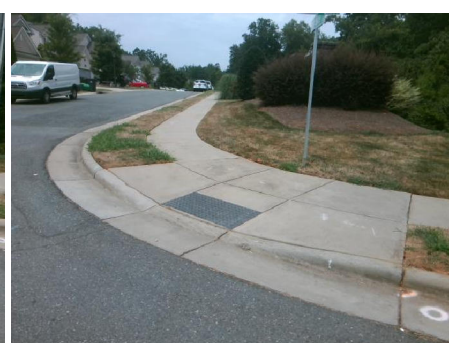
Not Found, R304.2.2, R304.5.3

Compliance	Description	Data	Compliance	Description	Data
N/A	Ramp Length (in)	48.5	No	Ramp Slope (%)	9.0
Yes	Ramp Width (in)	48.0	No	Ramp XSlope (%)	3.2
N/A	Flare Type LT	N/A	N/A	Flare Type RT	N/A
N/A	Flare Slope LT (%)	N/A	N/A	Flare Slope RT (%)	N/A
N/A	Flare Traversable LT?	N/A	N/A	Flare Traversable RT?	N/A
N/A	Landing Length (in)	N/A	N/A	DWS Provided?	N/A
N/A	Landing Width (in)	N/A	N/A	DWS Contrast?	N/A
N/A	Landing Slope (%)	N/A	N/A	DWS Length (in)	N/A
N/A	Landing X Slope (%)	N/A	N/A	DWS Full Width?	N/A
N/A	Landing Curb? (Y/N)	N/A	N/A	DWS Offset (in)	N/A
N/A	Shared Landing?	N/A			
N/A	Gutter Ponding?	N/A	N/A	Gutter Slope (%)	N/A
N/A	Gutter Lip Ht (in)	N/A	N/A	Gutter X Slope (%)	N/A
N/A	Painted X Walk1?	No	N/A	Painted X Walk2?	N/A
	X Walk 1 Direction	To W		X Walk 2 Direction	N/A
N/A	X Walk 1 Width (in)	N/A	N/A	X Walk 2 Width (in)	N/A
	X Walk 1 Slope (%)	0.7		X Walk 2 Slope (%)	N/A
	X Walk 1 X Slope (%)	3.7		X Walk 2 X Slope (%)	N/A

N/A	Ramp inside XWalk1?	N/A	N/A	Ramp inside XWalk2?	N/A
	Road Slope (%)	N/A	N/A	Clear Space?	N/A
	Road X Slope (%)	N/A	N/A	Clear Space to XWalk (in)	N/A
N/A	Any Obstructions?	N/A	N/A	Storm Grate/Utility Hazard?	N/A
	Obstruction Type			Storm Grate/Utility Type	
		N/A			N/A
			Yes	Surface Condition? (G/P)	Good

Remove & Replace Entire Ramp.

Total Cost: \$ 1850.00
