# Access Compliance Report

## Public Rights-of-Way

### (Curb Ramps)

| Intersection ID: 10029532 | Main Street: KESSLER_DR | Cross Street: N/A | Location: SE |

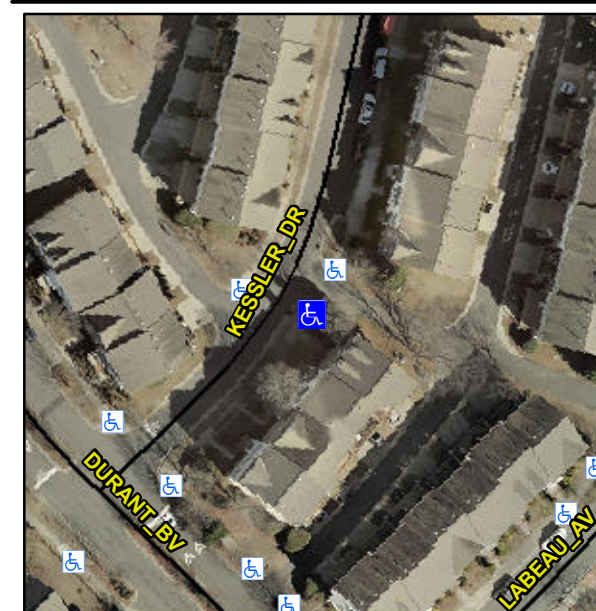
| ADA ID: 4DE5860AA5C4 | Ramp Type: PerpDiag | Initial Pass/Fail: Fail | Overall Compliance: No |
| Severity Score: 18.75 | | | |

**Not Found, R304.5.1, R304.5.3**

| Compliance | Description | Data | Compliance | Description | Data |
|---|---|---|---|---|---|
| N/A | Ramp Length (in) | 82.0 | Yes | Ramp Slope (%) | 7.3 |
| No | Ramp Width (in) | 32.0 | No | Ramp XSlope (%) | 4.0 |

**Remove & Replace Curb Ramp With Two New Directional Ramps or Equivalent.**
