# Access Compliance Report

## Public Rights-of-Way

### (Curb Ramps)

| Intersection ID: 12056 | Main Street: ELLIOTT_ST | Cross Street: N_I-77_EXIT_10A_RA | Location: NE |

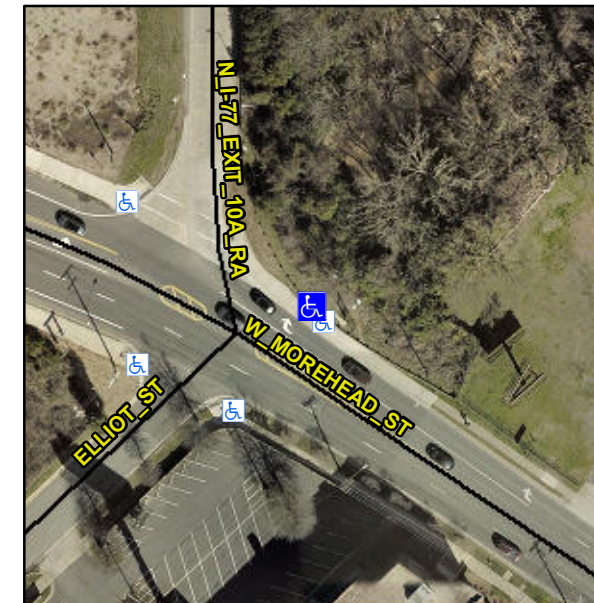
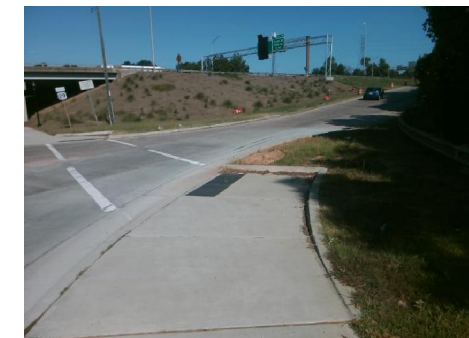
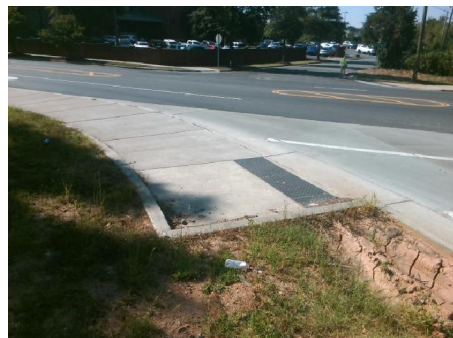
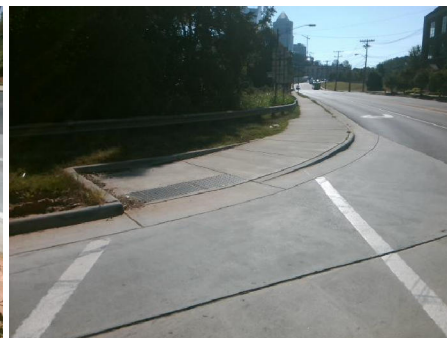
| | | Severity Score: 10 | |

**RT RP < 5%**

**R304.2.1, R304.2.2-Perp, R304.3.2-Para, R304.5.3, R305.2**

| Compliance | Description | Data | Compliance | Description | Data |
|---|---|---|---|---|---|
| No | Landing Length (in) | N/A | Yes | DWS Provided? | Yes |
| No | Landing Width (in) | N/A | Yes | DWS Contrast? | Yes |
| No | Landing Slope (%) | N/A | Yes | DWS Length (in) | 24.0 |
| No | Landing X Slope (%) | N/A | Yes | DWS Full Width? | Yes |
| N/A | Landing Curb? (Y/N) | Yes | No | DWS Offset (in) | 4.0 |

**Remove & Replace Entire Ramp.**

Total Cost: \$ 1600.00
