# Access Compliance Report

## Public Rights-of-Way

### (Curb Ramps)

| Intersection ID: 16719 | Main Street: CLOVERDALE_AV | Cross Street: MEADOWDALE_LN | Location: E |

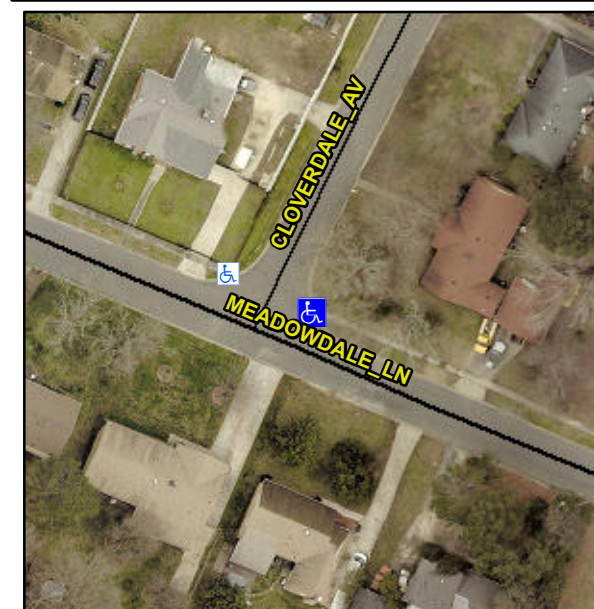
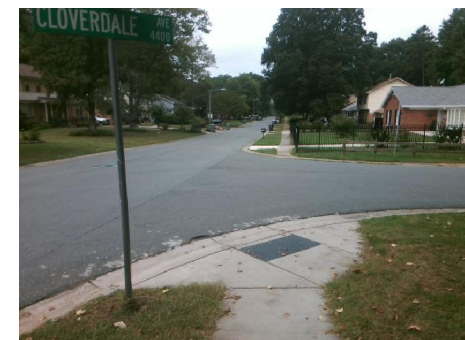
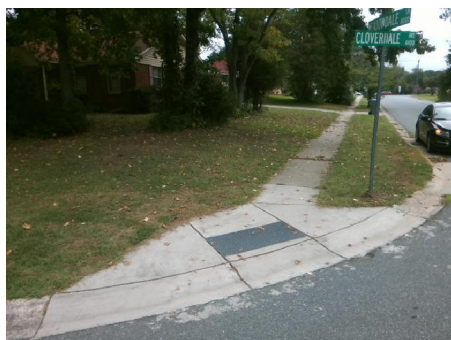
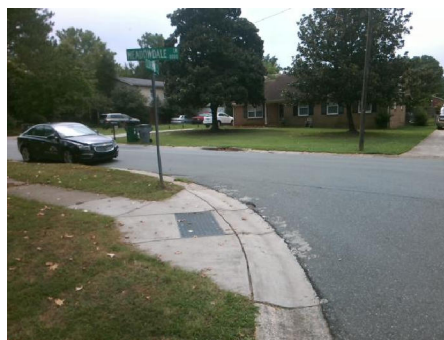
| ADA ID: 4DF318F4D518 | Ramp Type: BlendTrans2 | Initial Pass/Fail: Fail | Overall Compliance: No |

**Not Found, R304.5.1, R304.5.3**

| Compliance | Description | Data | Compliance | Description | Data |
|---|---|---|---|---|---|
| No | Ramp Width (in) | 47.0 | No | BlendTrans XSlope (%) | 5.8 |
| | | | No | Curb Slope (%) | 10.3 |

**Remove & Replace Curb Ramp With Two New Directional Ramps or Equivalent.**

Total Cost: \$ 3200.00
