# Access Compliance Report

## Public Rights-of-Way

| Intersection ID: 44824 | Main Street: CLANTON_RD | Cross Street: GOLDEN_RIDGE_LN | Location: NW |
| ADA ID: 4DFA7431A2C9 | Ramp Type: Perp | Initial Pass/Fail: Pass | Overall Compliance: No |

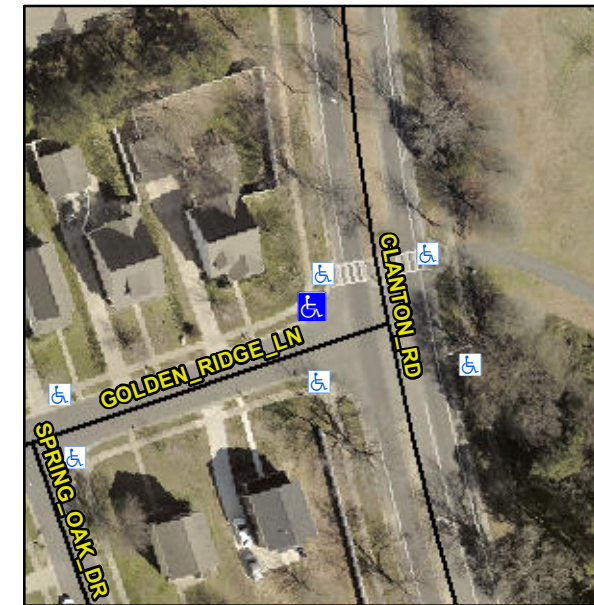
**Not Found, R304.2.1**

| Compliance | Description | Data | Compliance | Description | Data |
|---|---|---|---|---|---|
| No | Landing Length (in) | 46.0 | Yes | DWS Provided? | Yes |

Possible Solutions:

**Remove & Replace Entire Ramp.**

Total Cost: \$ 1850.00
